*Historic Structures Report*

Fort Point US Coast Guard Station  
Gulf of the Farallones National Marine Sanctuary

April 1, 2008

CAREY & CO. INC.  
ARCHITECTURE

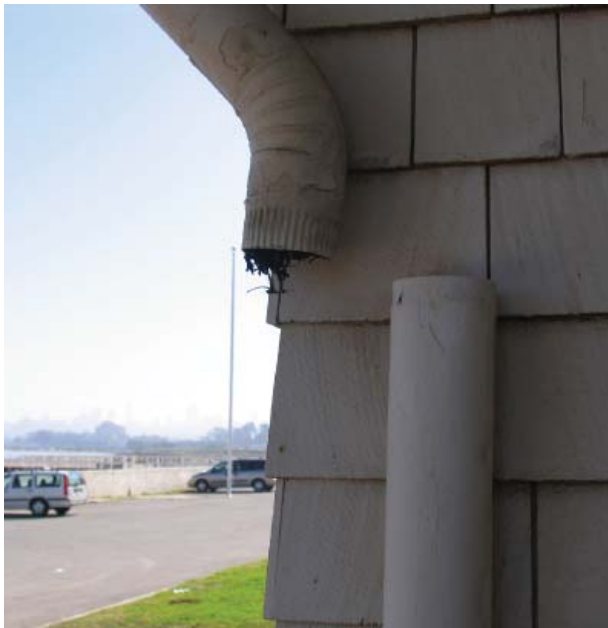
*Fig. 27 : Clogged drain at the 1890 Boathouse.*

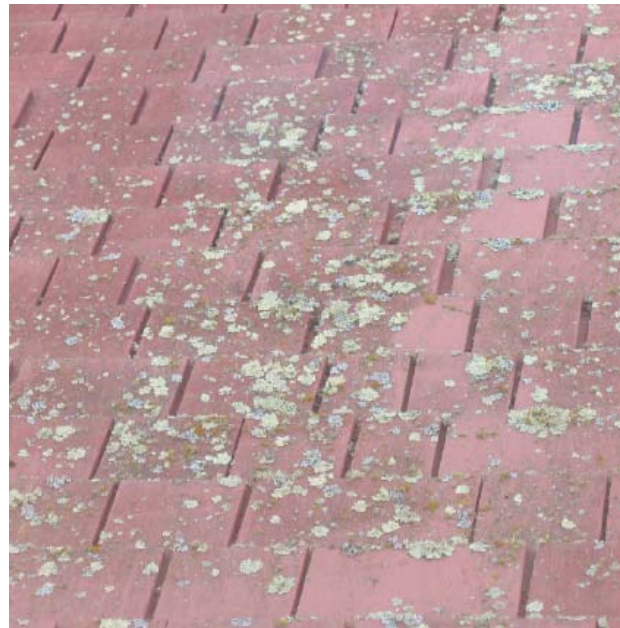
*Fig. 28 : Biological growth on the roof at the Main Boathouse.*

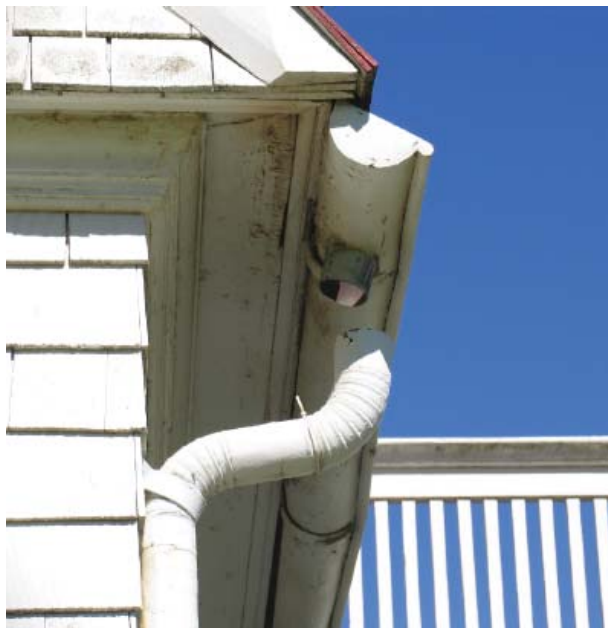
*Fig. 29 : Disconnected drain spout at the Officer in Charge Quarters.*

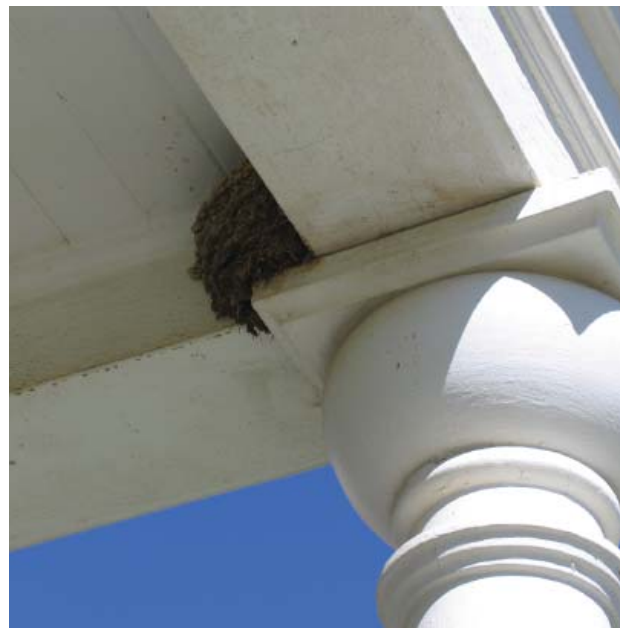
*Fig. 30 : Mud Swallows nesting in the eaves of the porch at the Officer in Charge Quarters.*

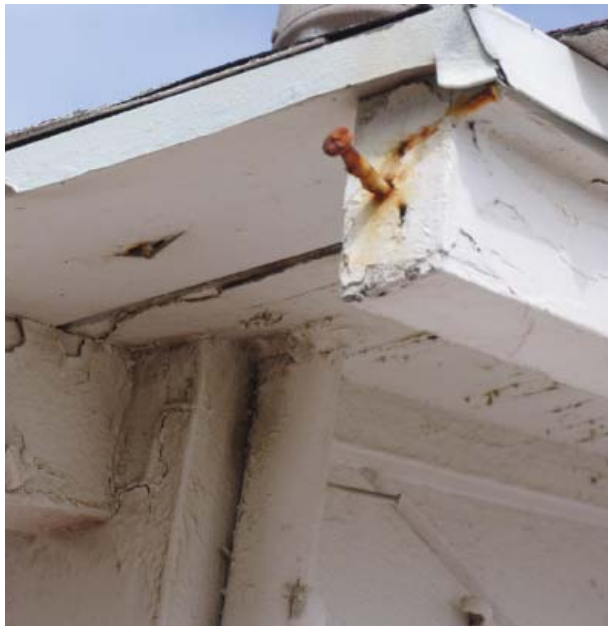
- Figure 31. Photograph: Buoy Shack, 2007. Corroded ferrous metal attachments in rafter tails. Carey & Co., Inc.
- Figure 32. Photograph: Buoy Shack, 2007. Deteriorated substrate below paint layer. Carey & Co., Inc.

Fig. 31 : Corroded ferrous metal hardware at the Buoy Shack.

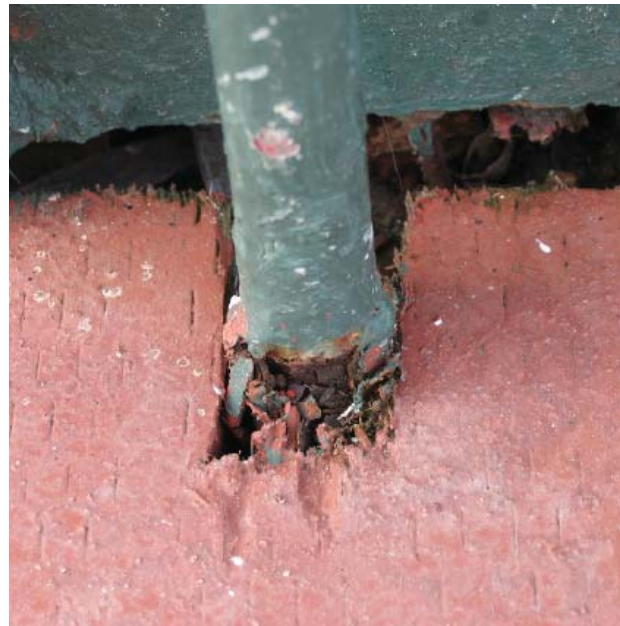
Fig. 32 :Substrate underneath deteriorated paint is deteriorating from rot.

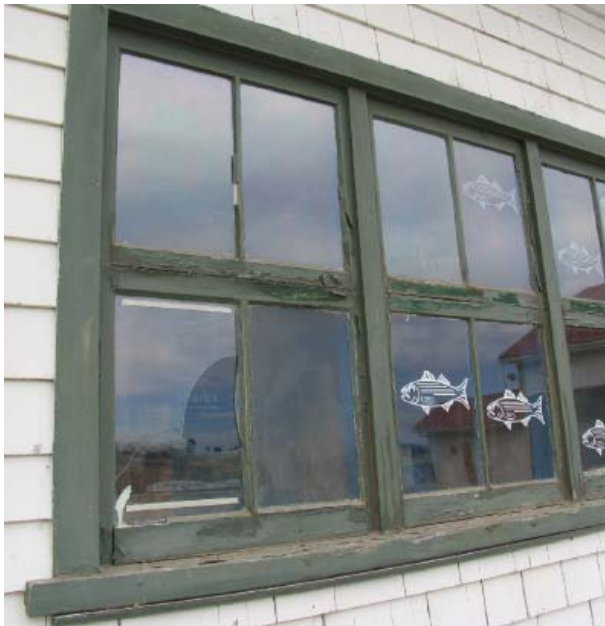
- Figure 33. Photograph: Main Boathouse, 2007. Exterior paint and glazing compound deterioration at the windows of the east enclosed porch. Carey & Co., Inc.

*Fig. 33 : The exterior paint is deteriorating on the windows, as is the glazing compound.*

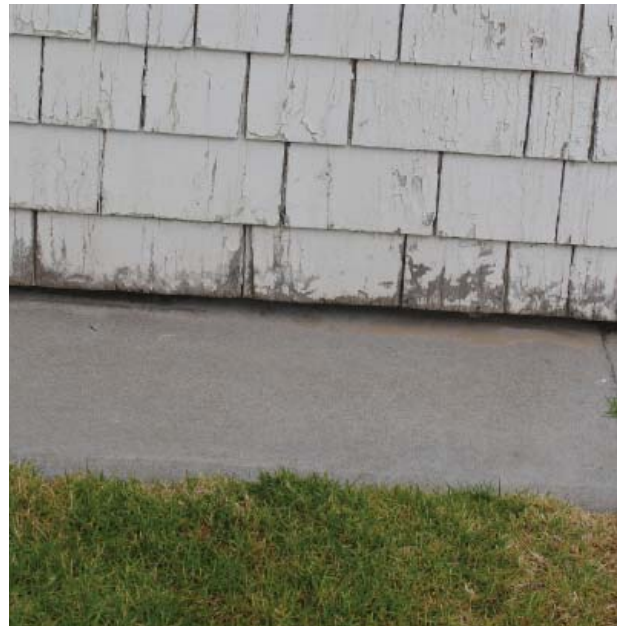
- Figure 34. Photograph: Main Boathouse, 2007. Improper drainage at grade leading to shingle deterioration. Carey & Co., Inc.
- Figure 35. Photograph: Main Boathouse, 2007. Biological growth developing in shaded areas near the water table. Carey & Co., Inc.

*Fig. 34: Improper drainage at grade has lead to shingle deterioration.*

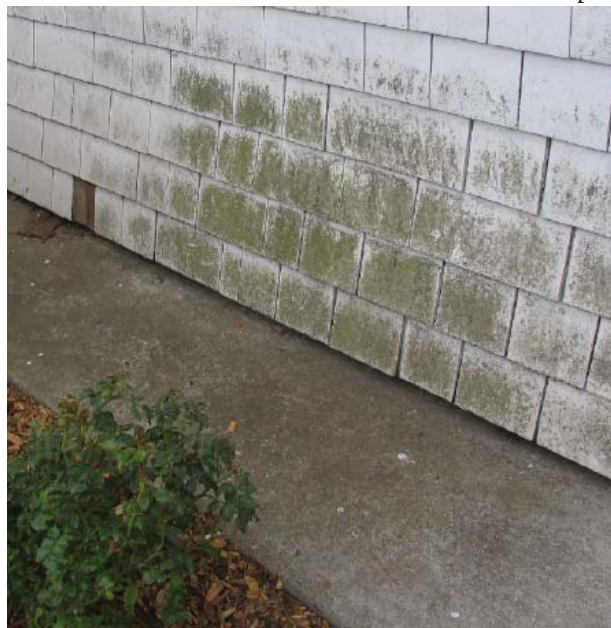
*Fig. 35 : Biological growth has developed in moist, shaded areas*

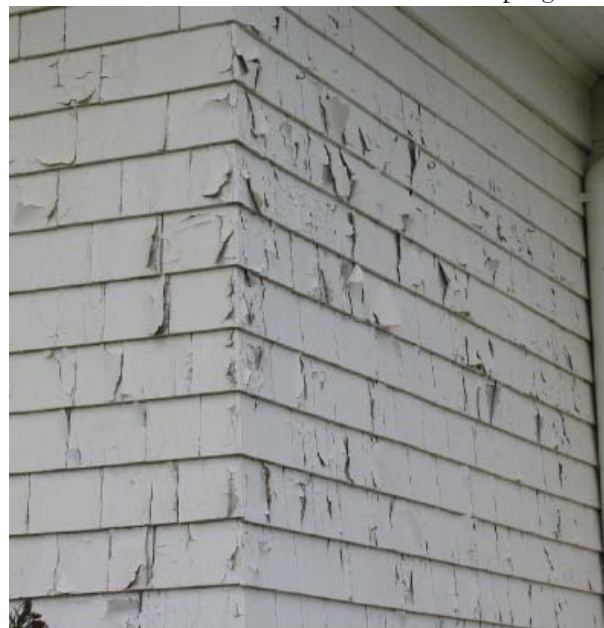
- Figure 36. Photograph: Main Boathouse, 2007. Paint failure on the shingle siding in close proximity with vegetation. Carey & Co., Inc.

*Fig. 36 : Much of the paint has detached from the shingle siding.*

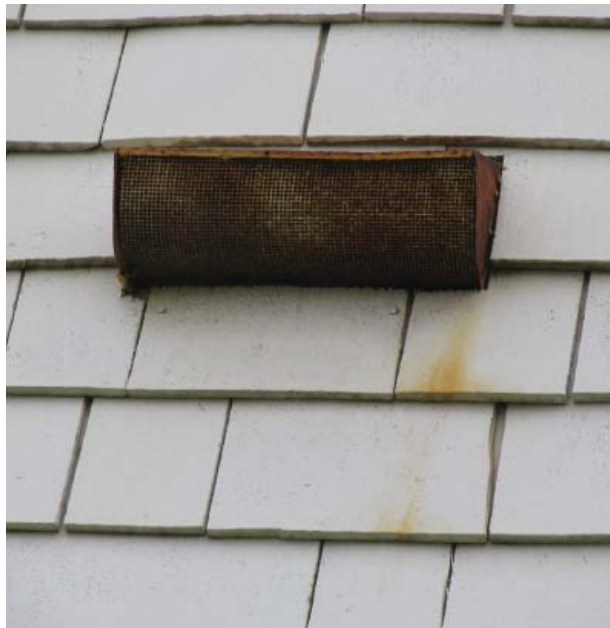
*Fig. 39 : Rust stains are evident in the shingled areas.*

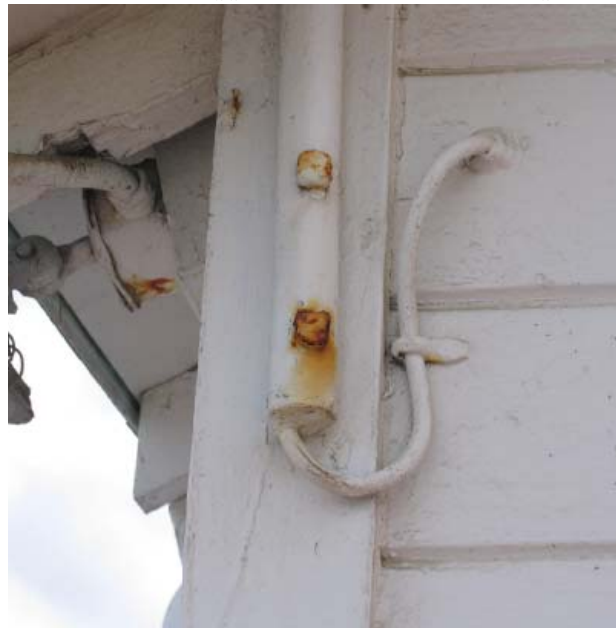
*Fig. 40 : Corroded ferrous metal hardware is embedded in the shingles*

- Avoid sparse shingle coverage and heavy building papers.
- Avoid staples and inferior flashing. Use stainless steel nails instead. Stainless steel and copper

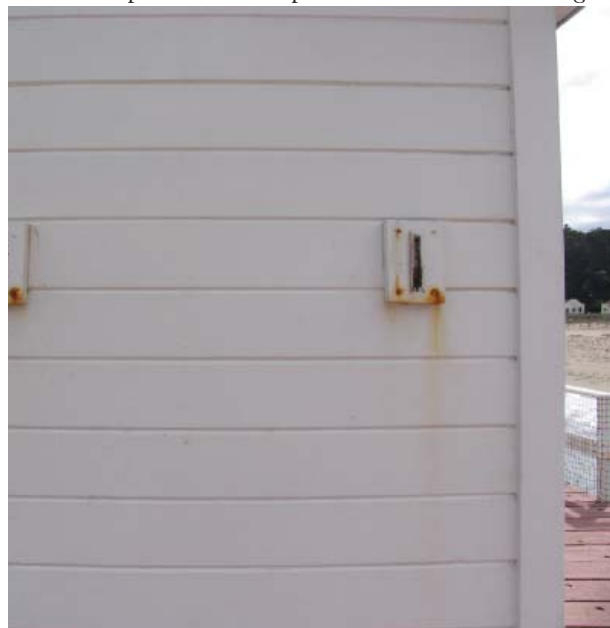
Fig. 43: Corrosion staining from embedded hardware at the Buoy Shack

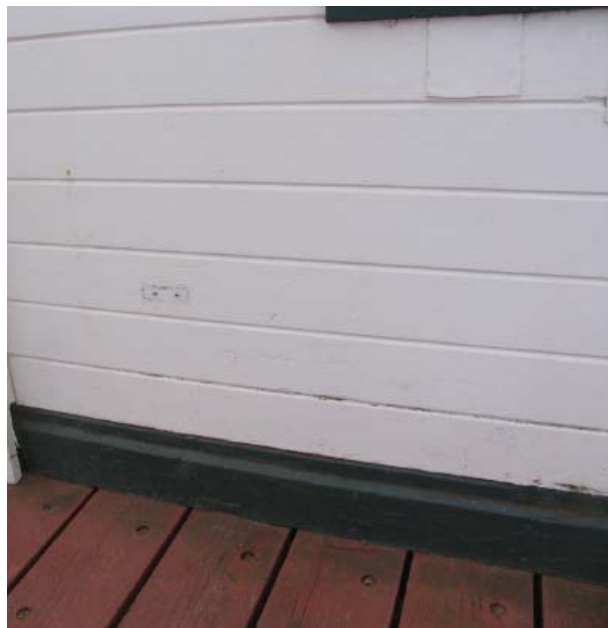
Fig. 44: Inappropriate patching on clapboard wall at the Buoy Shack..

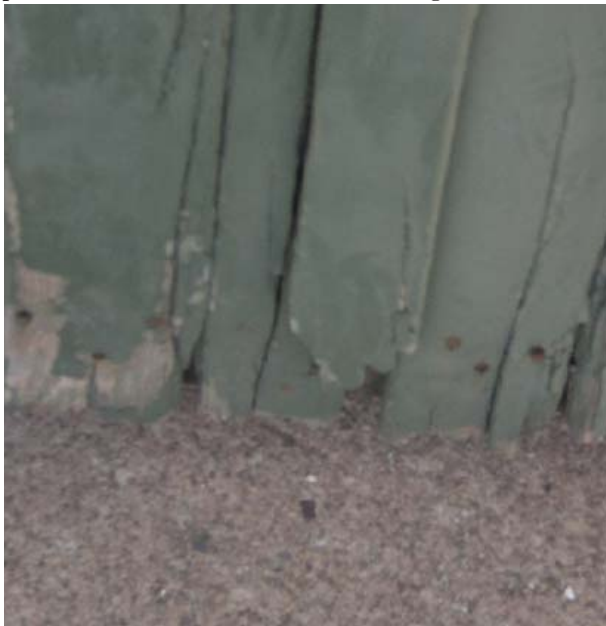
- Figure 44. Photograph: Buoy Shack, 2007. Inappropriate patching on clapboard wall. Carey & Co., Inc.
- Figure 45. Photograph: Shop & Garage, 2007. South garage doors exhibiting the mechanical deterioration associated with cross-grain dragging and water infiltration. Carey & Co., Inc.

*Fig. 45: Mechanical deterioration of doors of the Shop & Garage associated with cross-grain dragging.*

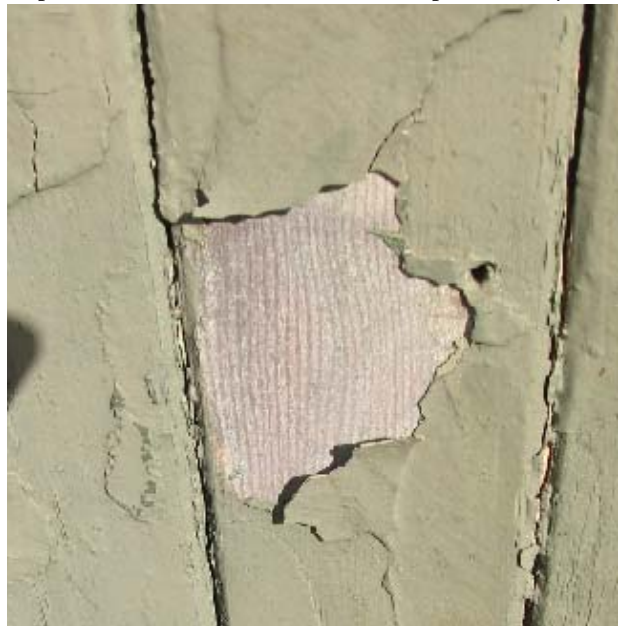
*Fig. 46: Paint failure on the doors of the Shop & Garage.*

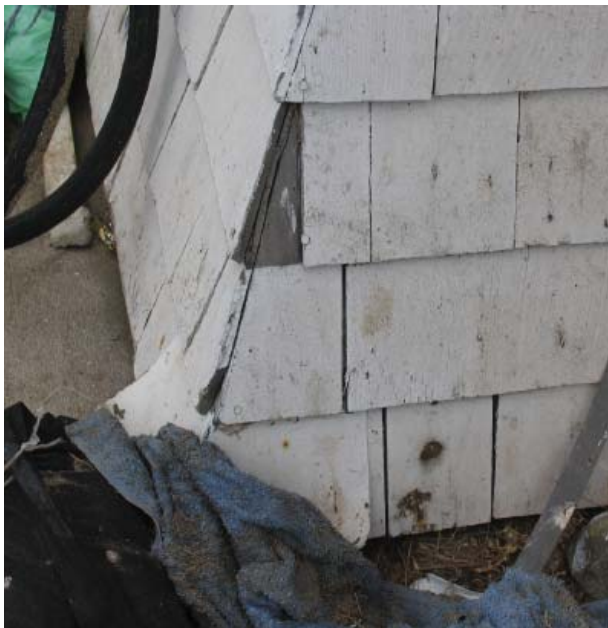
*Fig. 49: Loss of shingles at the sloped corner of the Main Boathouse*

Recommendation: The existing wall shingles are not severely deteriorated; however, there some are missing and should be replaced. These appear to be holding up well, however shingles have a finite life span, and will someday need to be replaced.

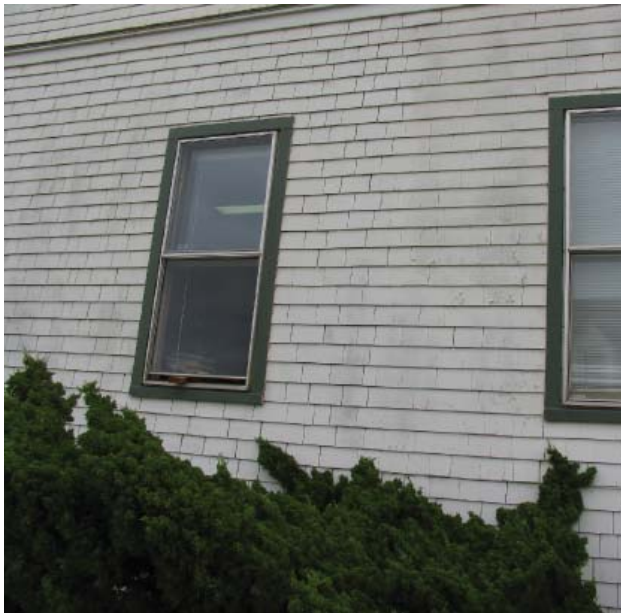
*Fig. 55: Vegetation at the south wall of the Main Boathouse.*

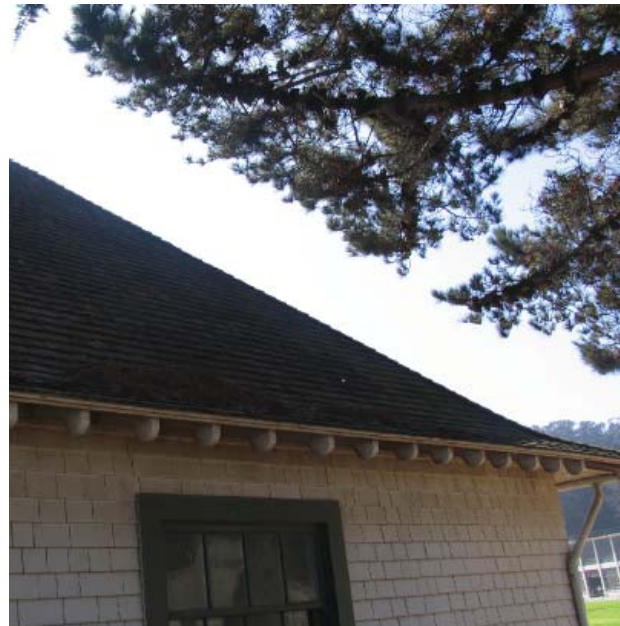
*Fig. 56: Overhanging tree limb at the 1890 Boathouse.*

Condition: Generally, the vegetation is well-kept. The trees could potentially cause damage in the event of strong winds. The trees to the west of the 1890 Boathouse and south of the Officer in Charge Quarters are close enough to hold moisture against the buildings and support biological growth (see figure 56).

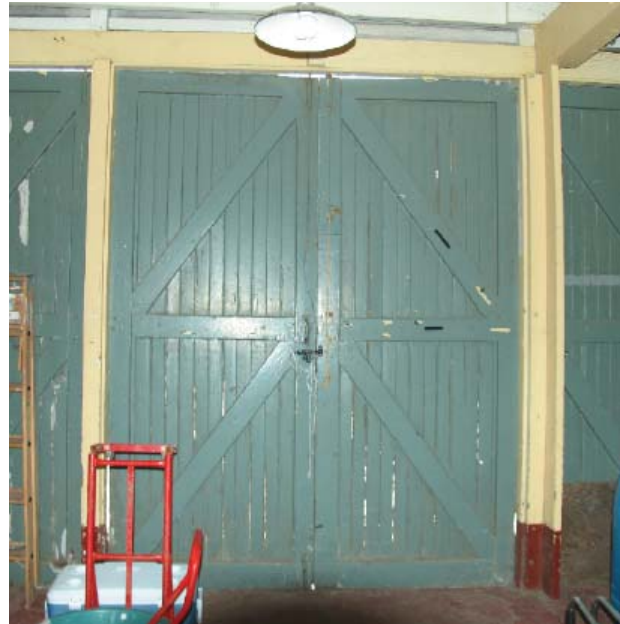
*Fig. 68 : The doors at the Shop & Garage appear to be in fair condition.*
