MARINE CASUALTY REPORT

TANKSHIP PUERTO RICAN

**EXPLOSION AND FIRE
IN THE PACIFIC OCEAN,
ON 31 OCTOBER 1984**

REPORT NO. USCG 16732/0003 HQS 84

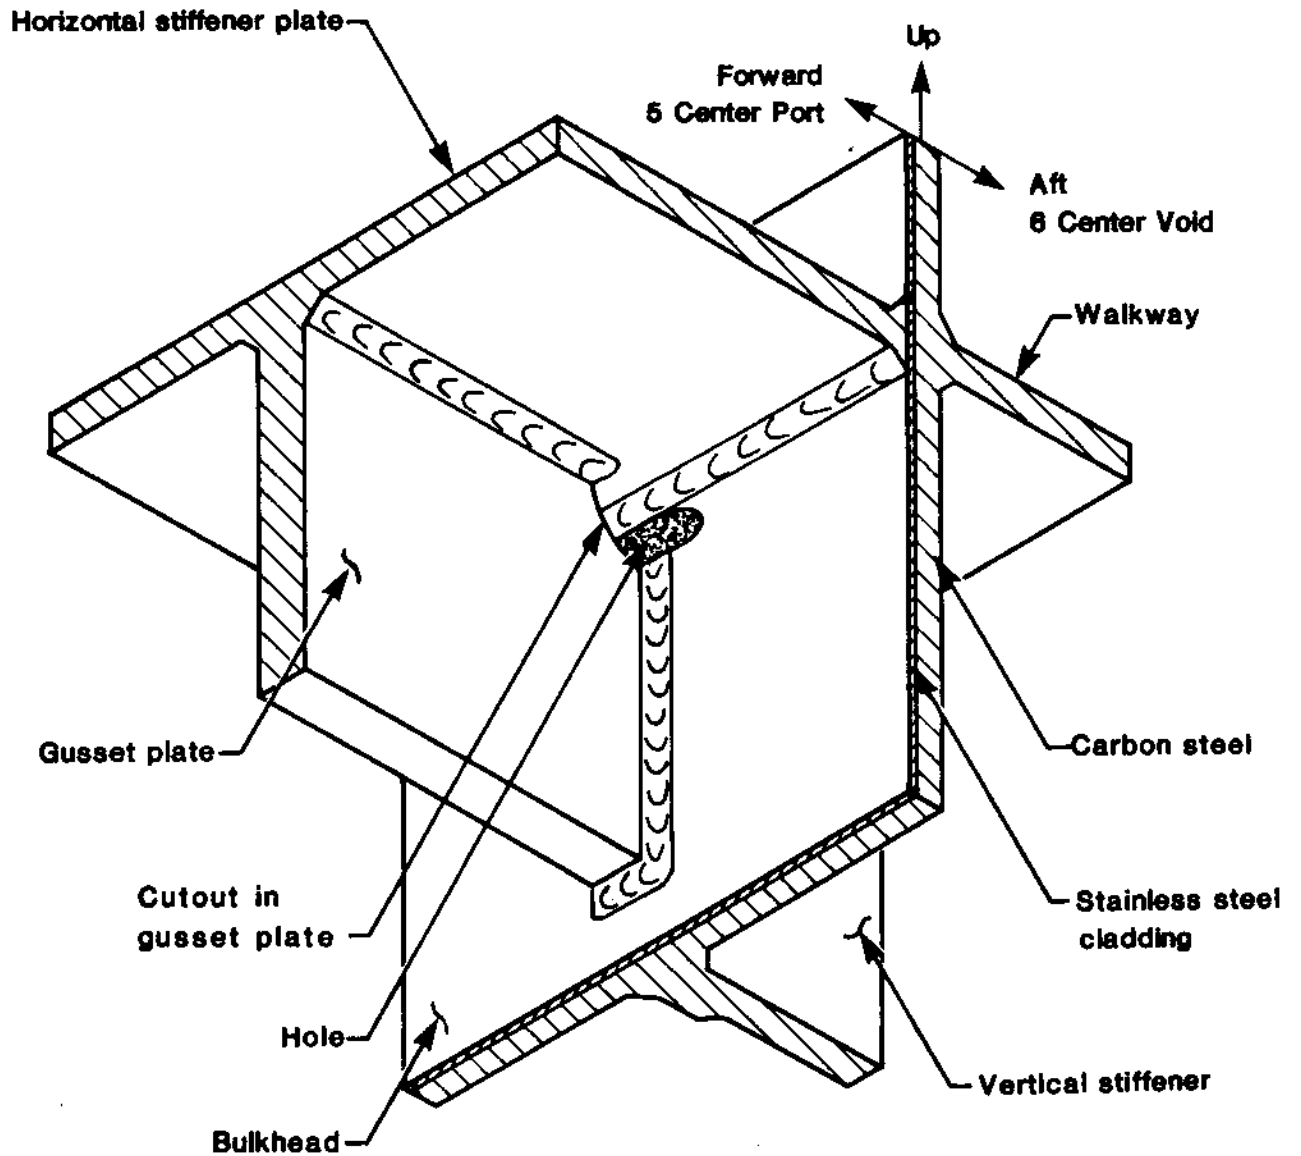
Figure 3. Sketch of hole in bulkhead between Tanks 5 Center Port (5CP) and 6 Center Void (6CV) for Case 1, seen from inside Tank 5CP below the hole.

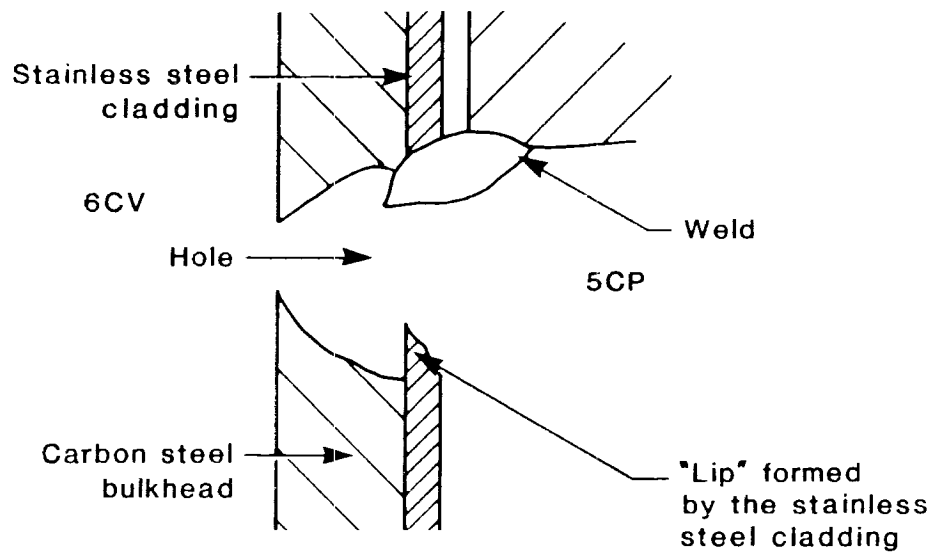
Figure 4. Schematic vertical cross section of the hole in the bulkhead between 6CV and 5CP.

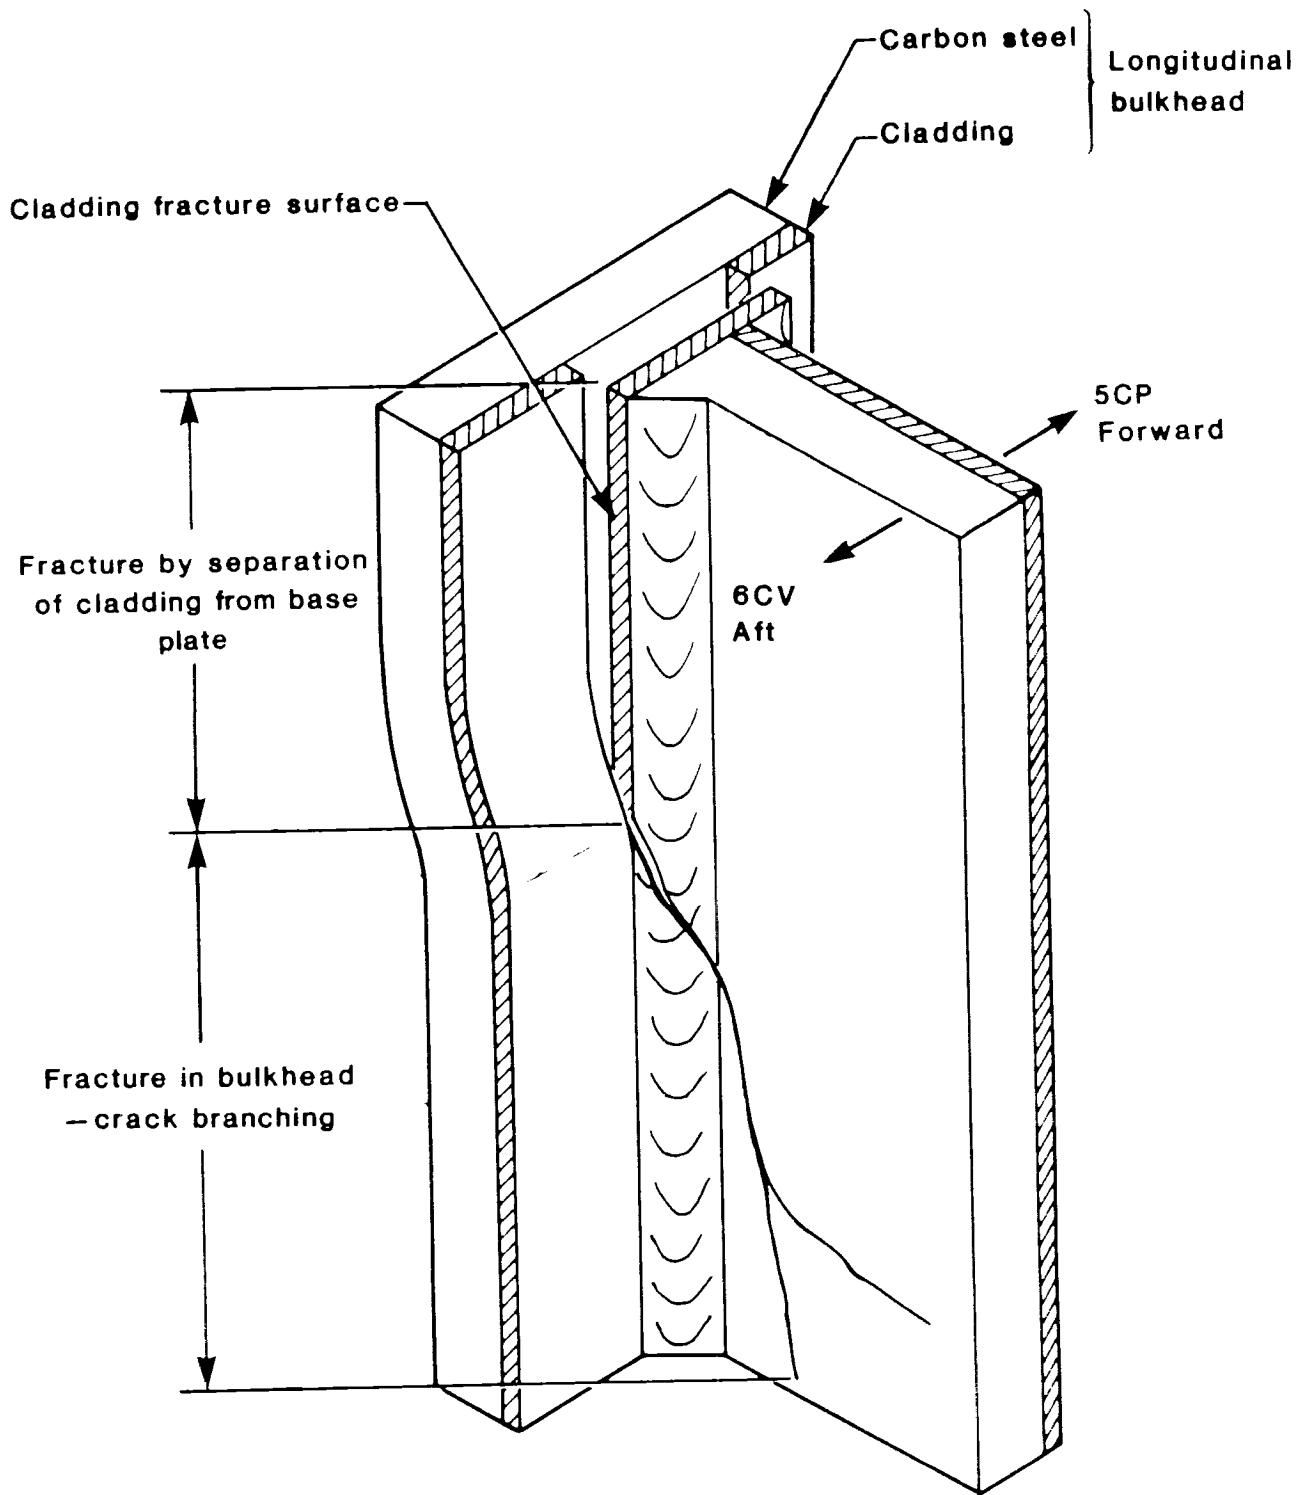
Figure 5. Sketch of different fracture paths in Cases 2 and 3.

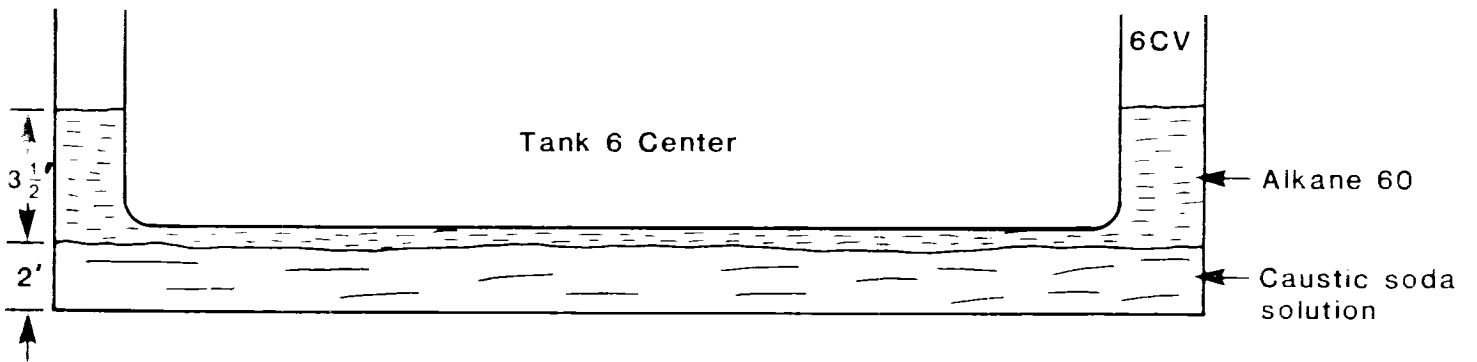
Figure 6. Schematic showing caustic soda solution and Alkane 60 in 6CV shortly before the casualty.

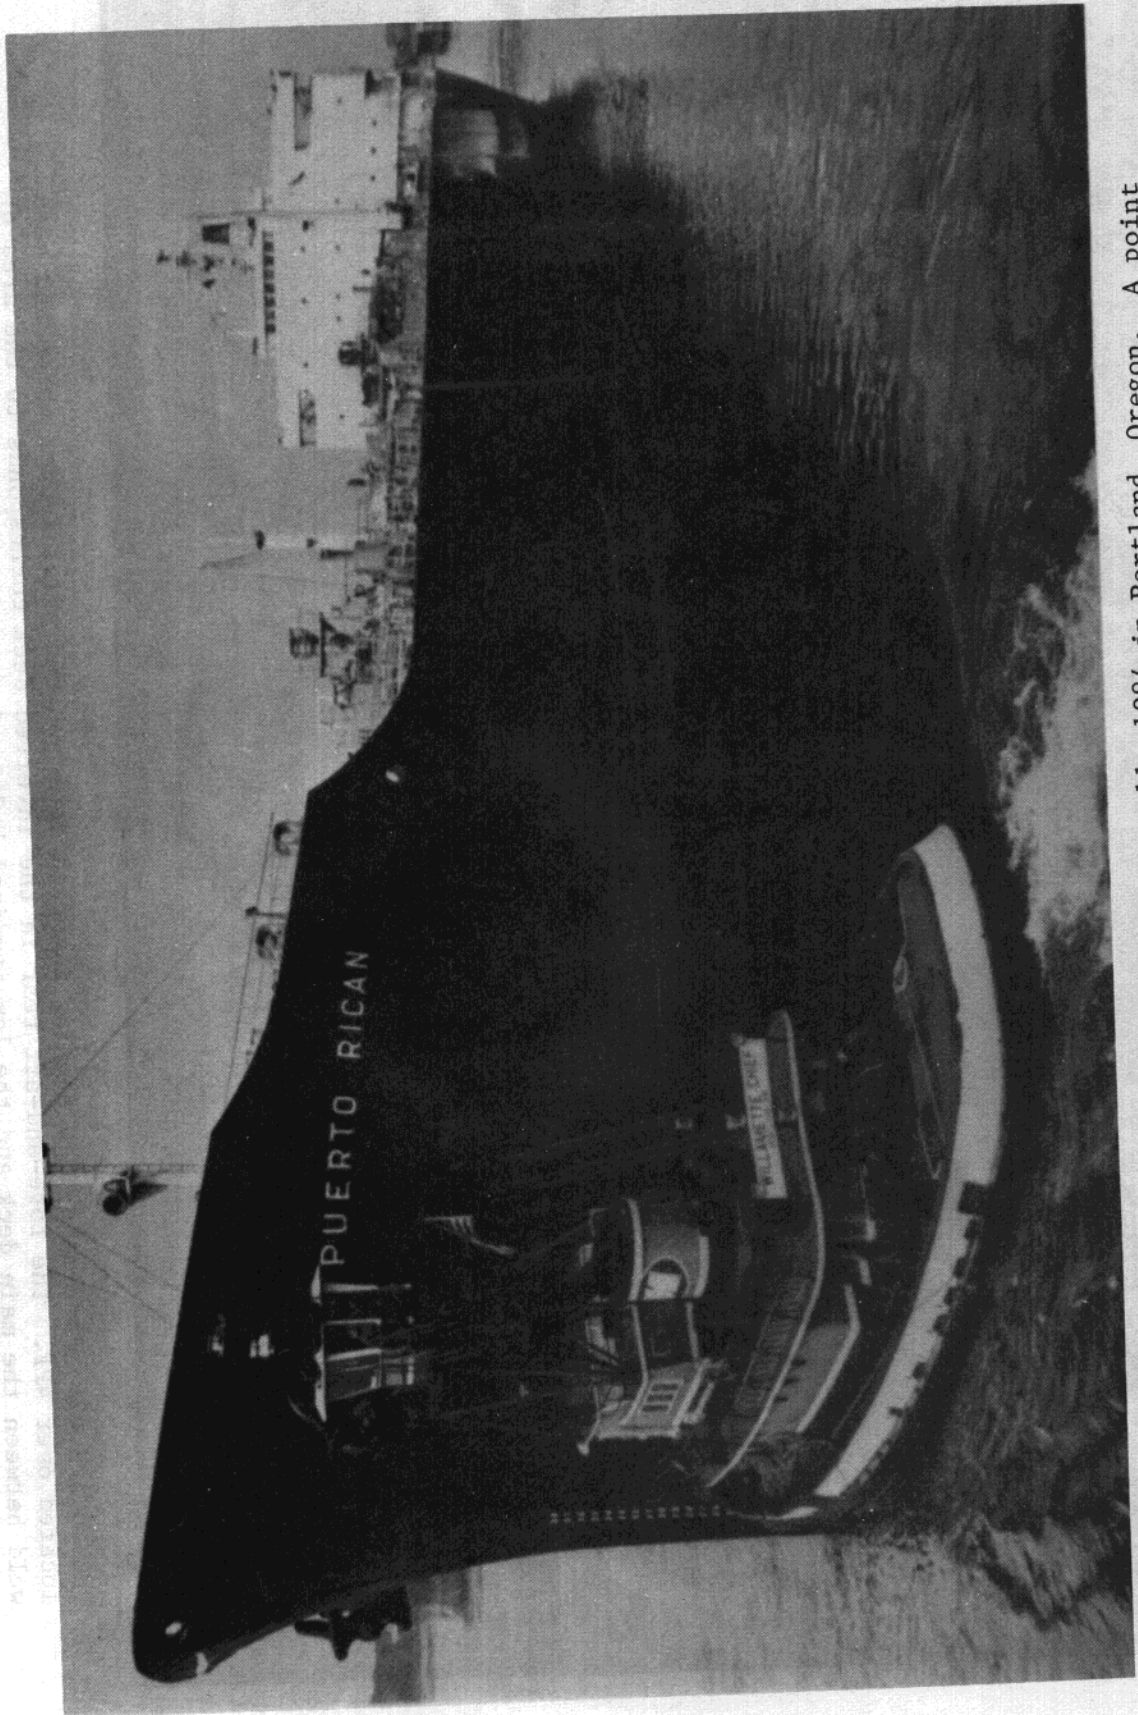
PHOTOGRAPH #1: The S.S. PUERTO RICAN on September 11, 1984 in Portland, Oregon. A point of interest is the light colored area on the hull aft of the kingpost. This appears to be in way of the number 4 port wing tanks. The Board could not determine the reason for this discoloration. (LAARS Photography Photo)

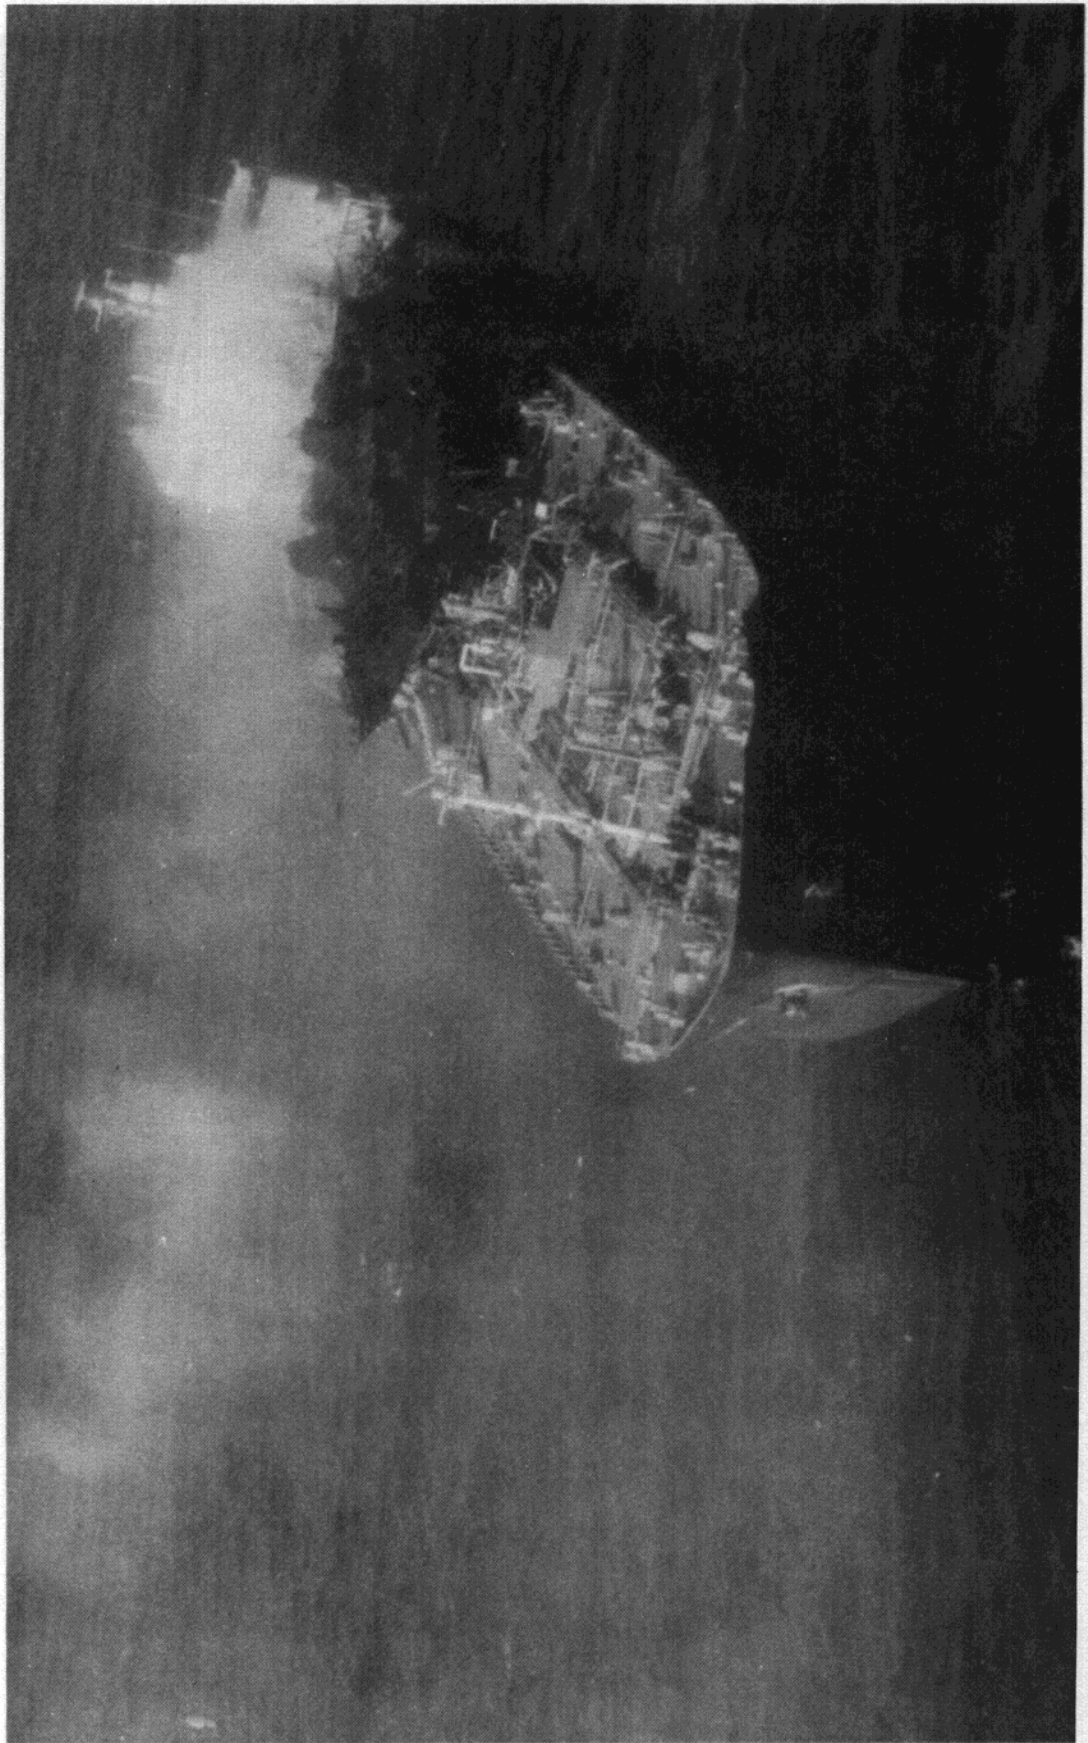
numbers 4 and 5 center tanks and the adjacent wing tanks. This condition is shown in photographs 3, 4, and 5.

PHOTOGRAPH #3: PUERTO RICAN under tow on October 31, 1984 at approximately 1030 in position
approximately 15.5 miles and 250°T from Point Bonita. (USCG Photo)

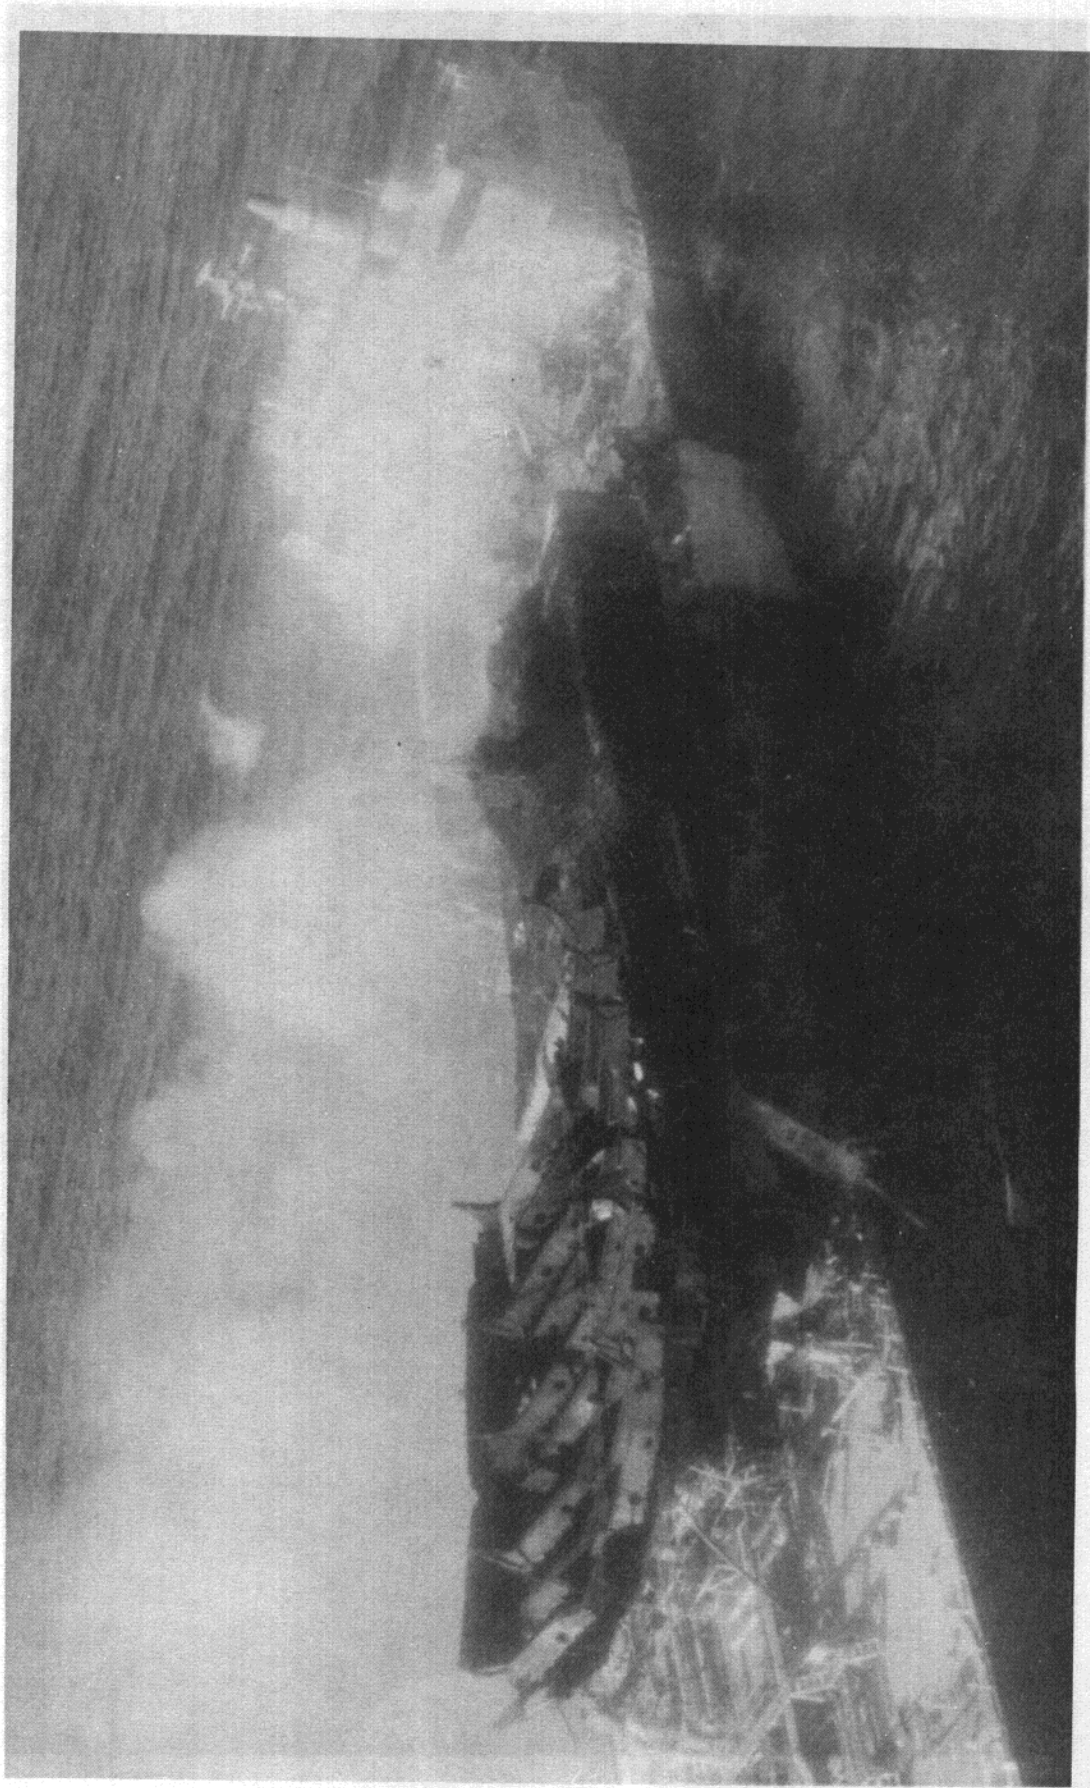
PHOTOGRAPH #4: PUERTO RICAN under tow on October 31, 1984 at approximately 1030 in position approximately 15.5 miles and 250°T from Point Bonita. (USCG Photo)

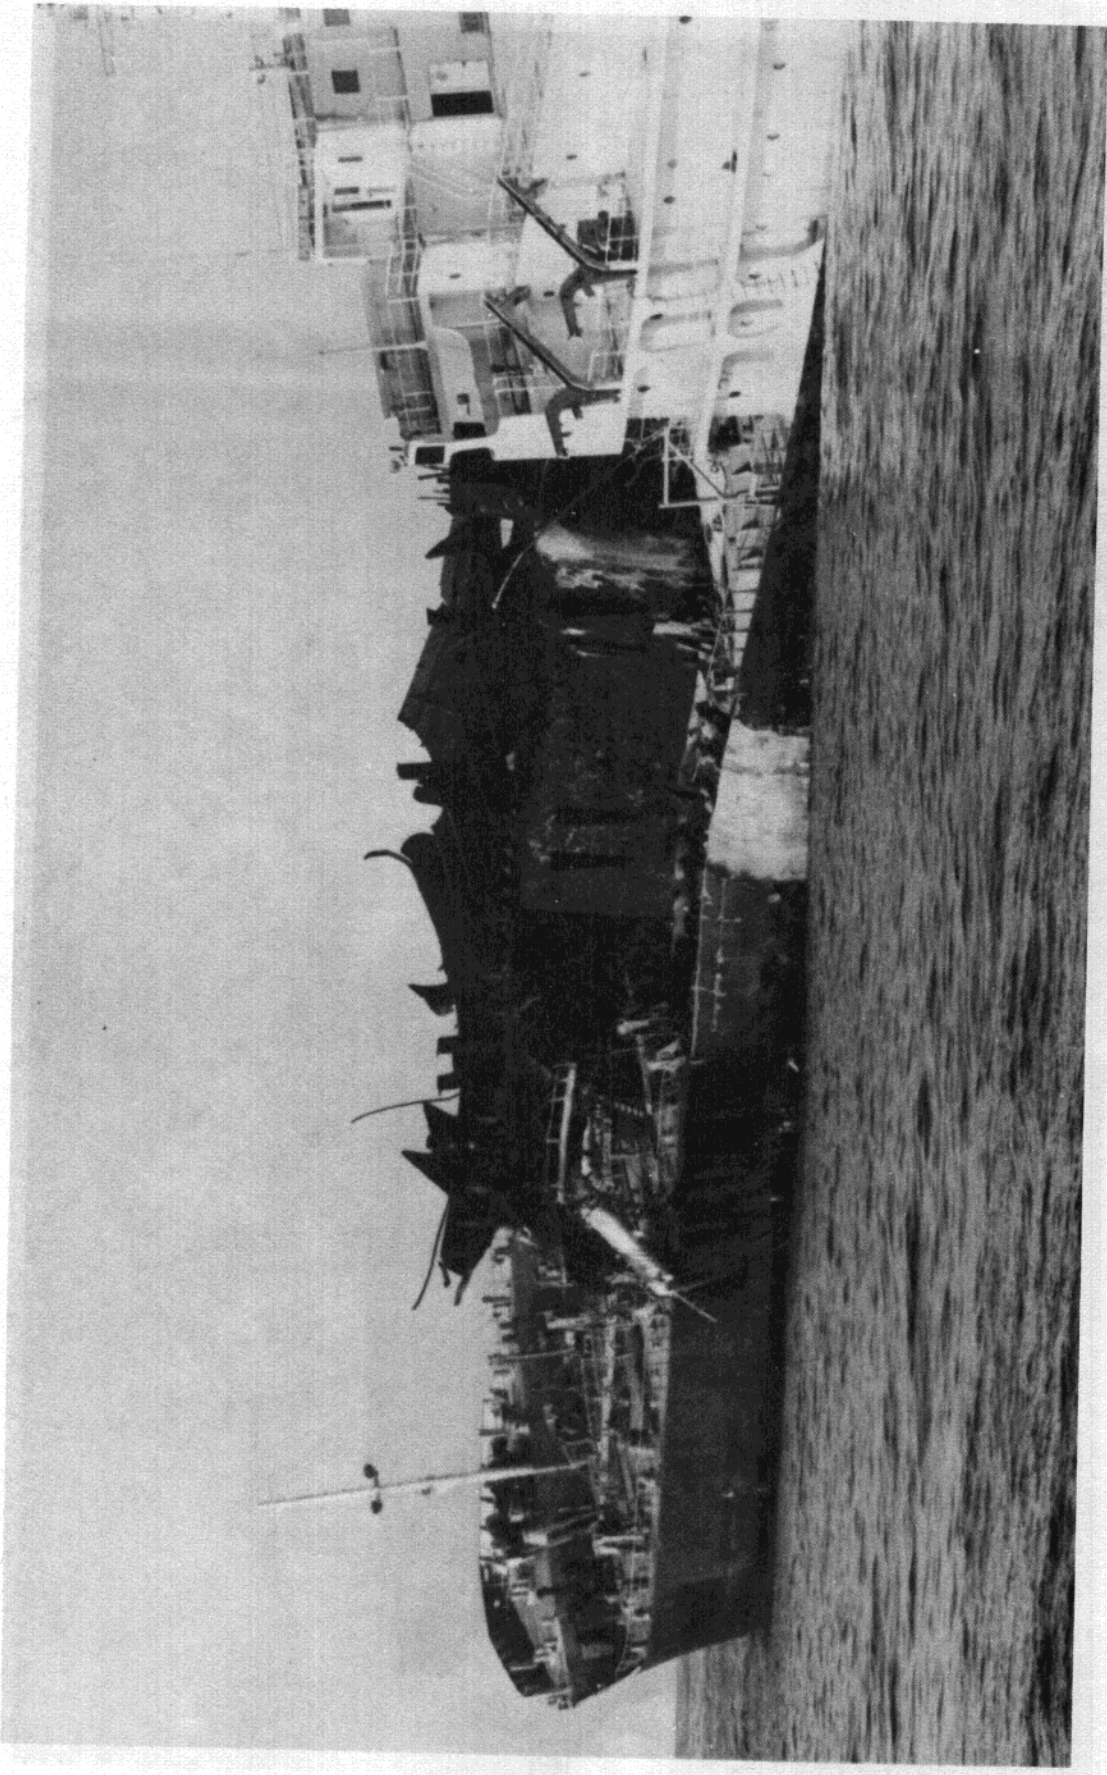
PHOTOGRAPH #8: PUERTO RICAN under tow on November 1, 1984 at approximately 0930 in position approximately 35.5 miles at 215°T from Point Bonita. The swell in the foreground gives the illusion that the stern is awash. The angular difference at the gunwale shows the area where the forebody separated from the stern on the port side at the main deck. (USCG Photo)

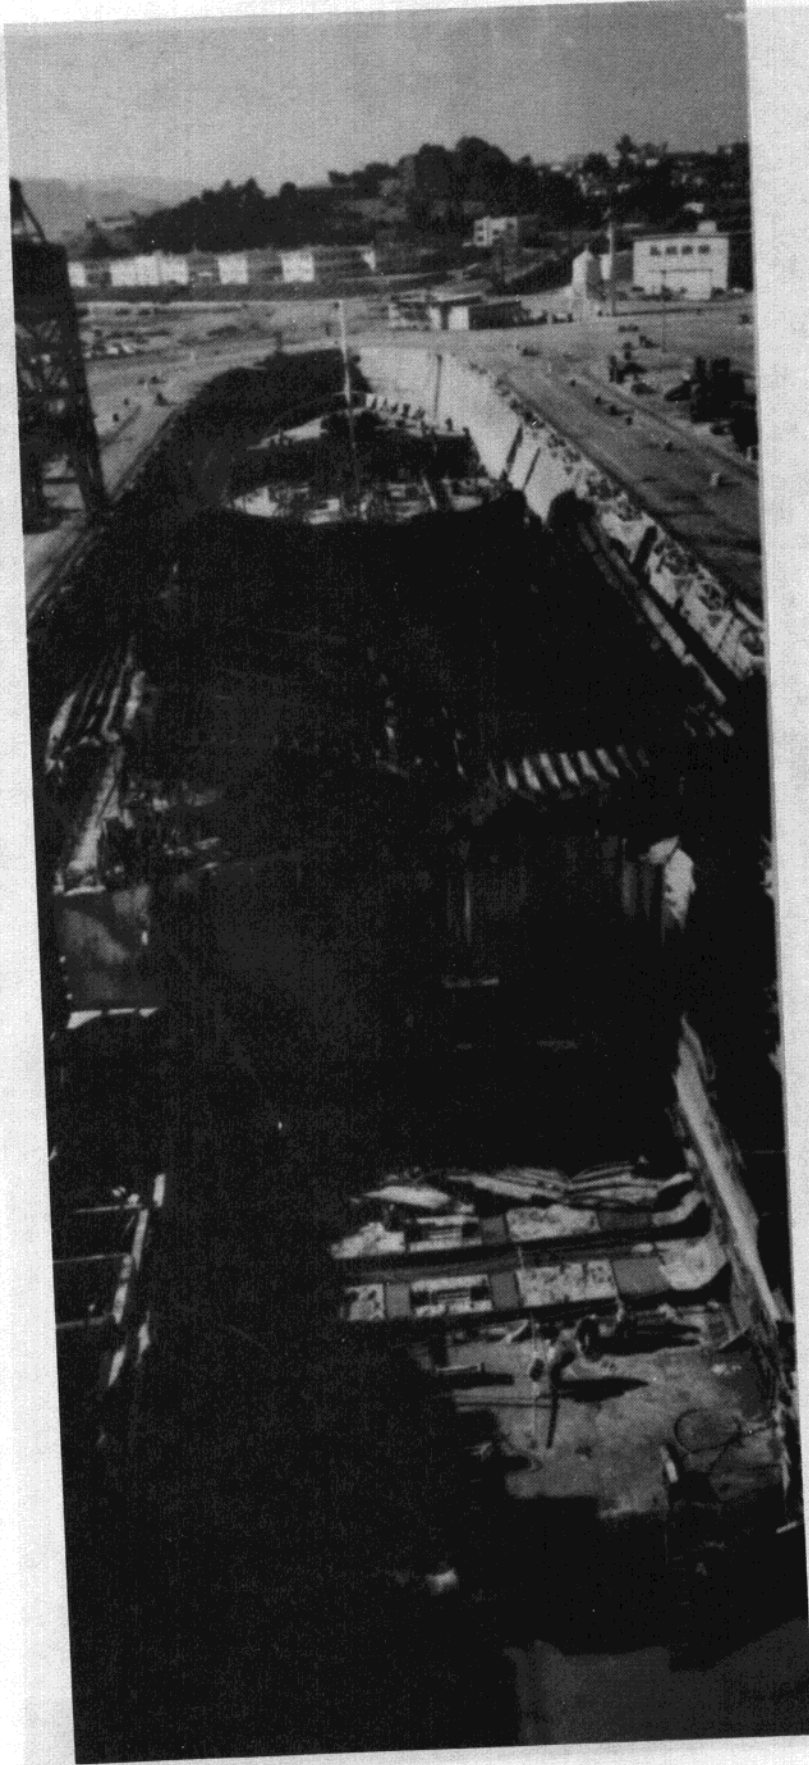
PHOTOGRAPH #9: View of forebody taken January 16, 1985 in Triple A Shipyard, San Francisco, California showing 6CV and the inverted deck. The man in the approximate center of the photograph shown standing at the forward end of 6CV on the second transverse bulkhead stiffener is at the location of the hole found between 5CP and 6CV. (Fa AA Photo)

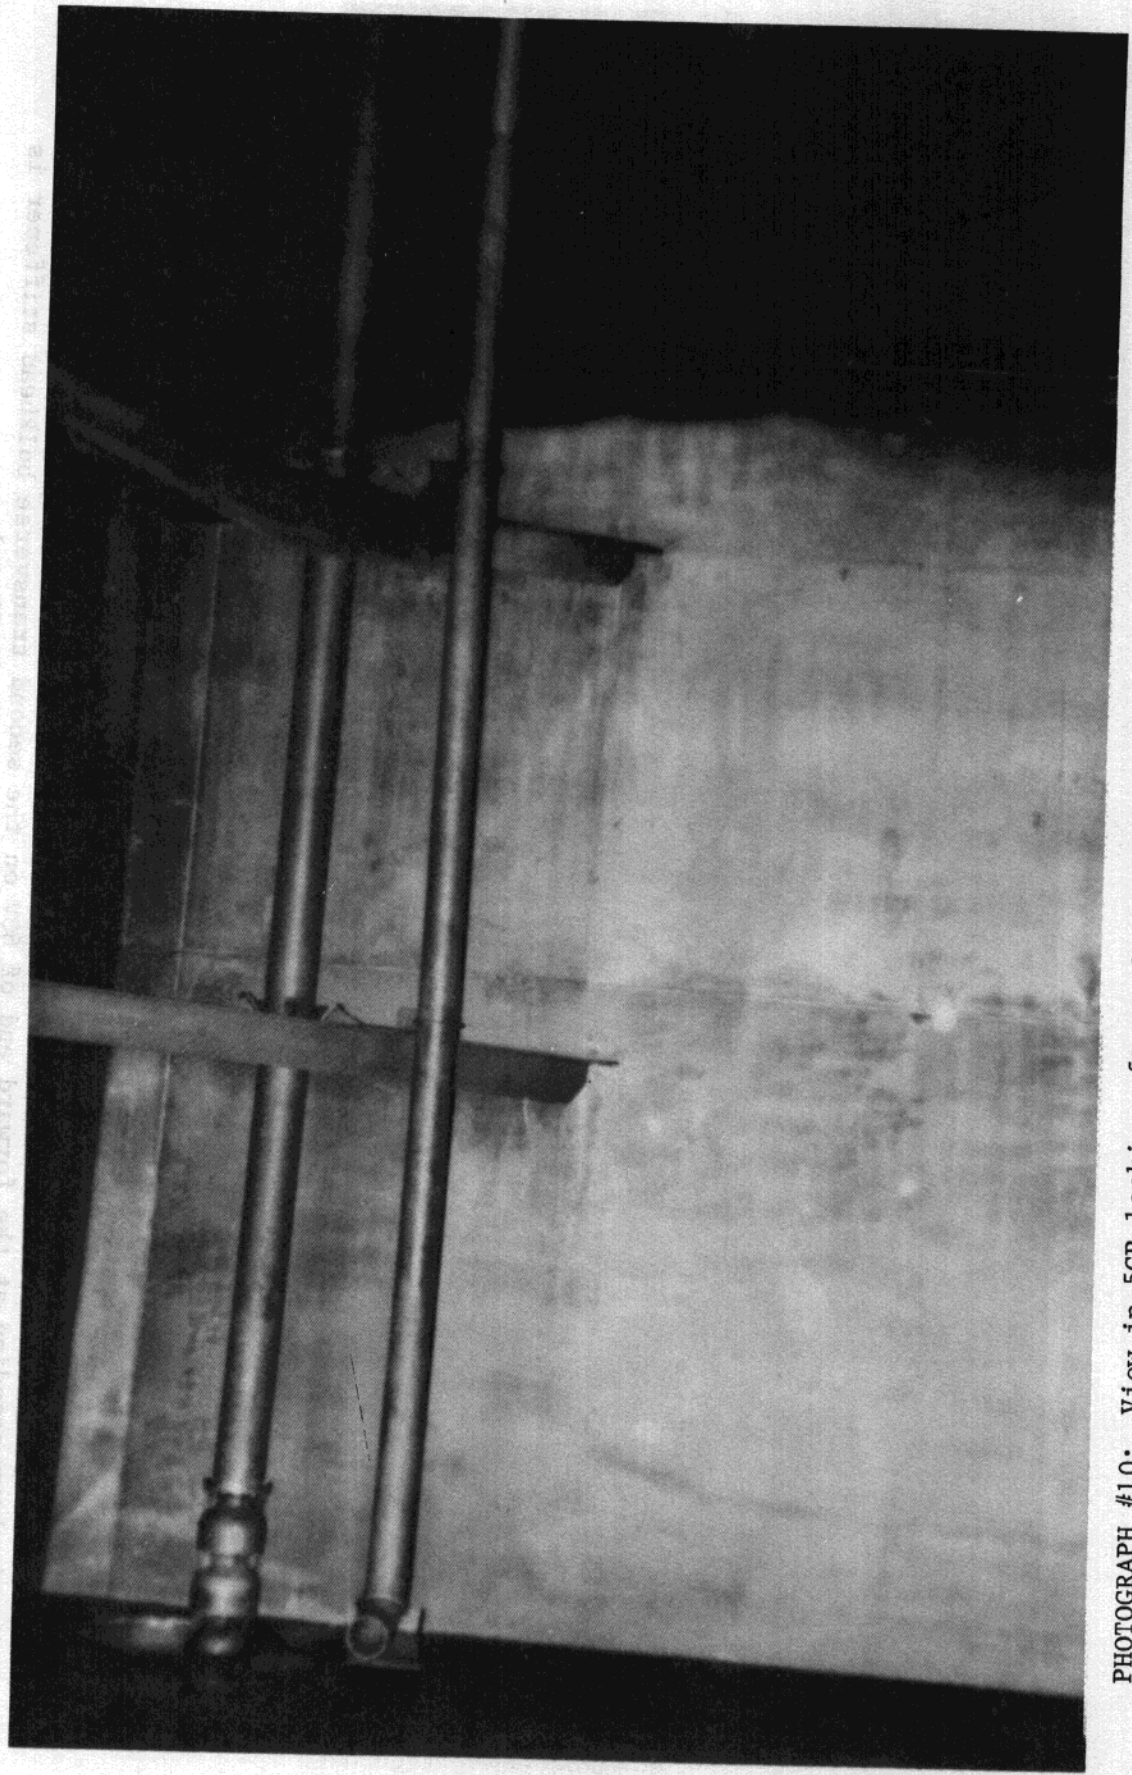
PHOTOGRAPH #10: View in 5CP looking aft at the bulkhead between 5CP and 6CV where it joins the centerline bulkhead. The hole is located just inboard of the end of the second horizontal corner bracket, which is 16'6" from the deck, and outboard of the center longitudinal bulkhead. This location is shown by letter "A". Note the fire effected zone on the bulkhead approximately 18' above the deck. (Fa AA Photo taken November 19, 1984)

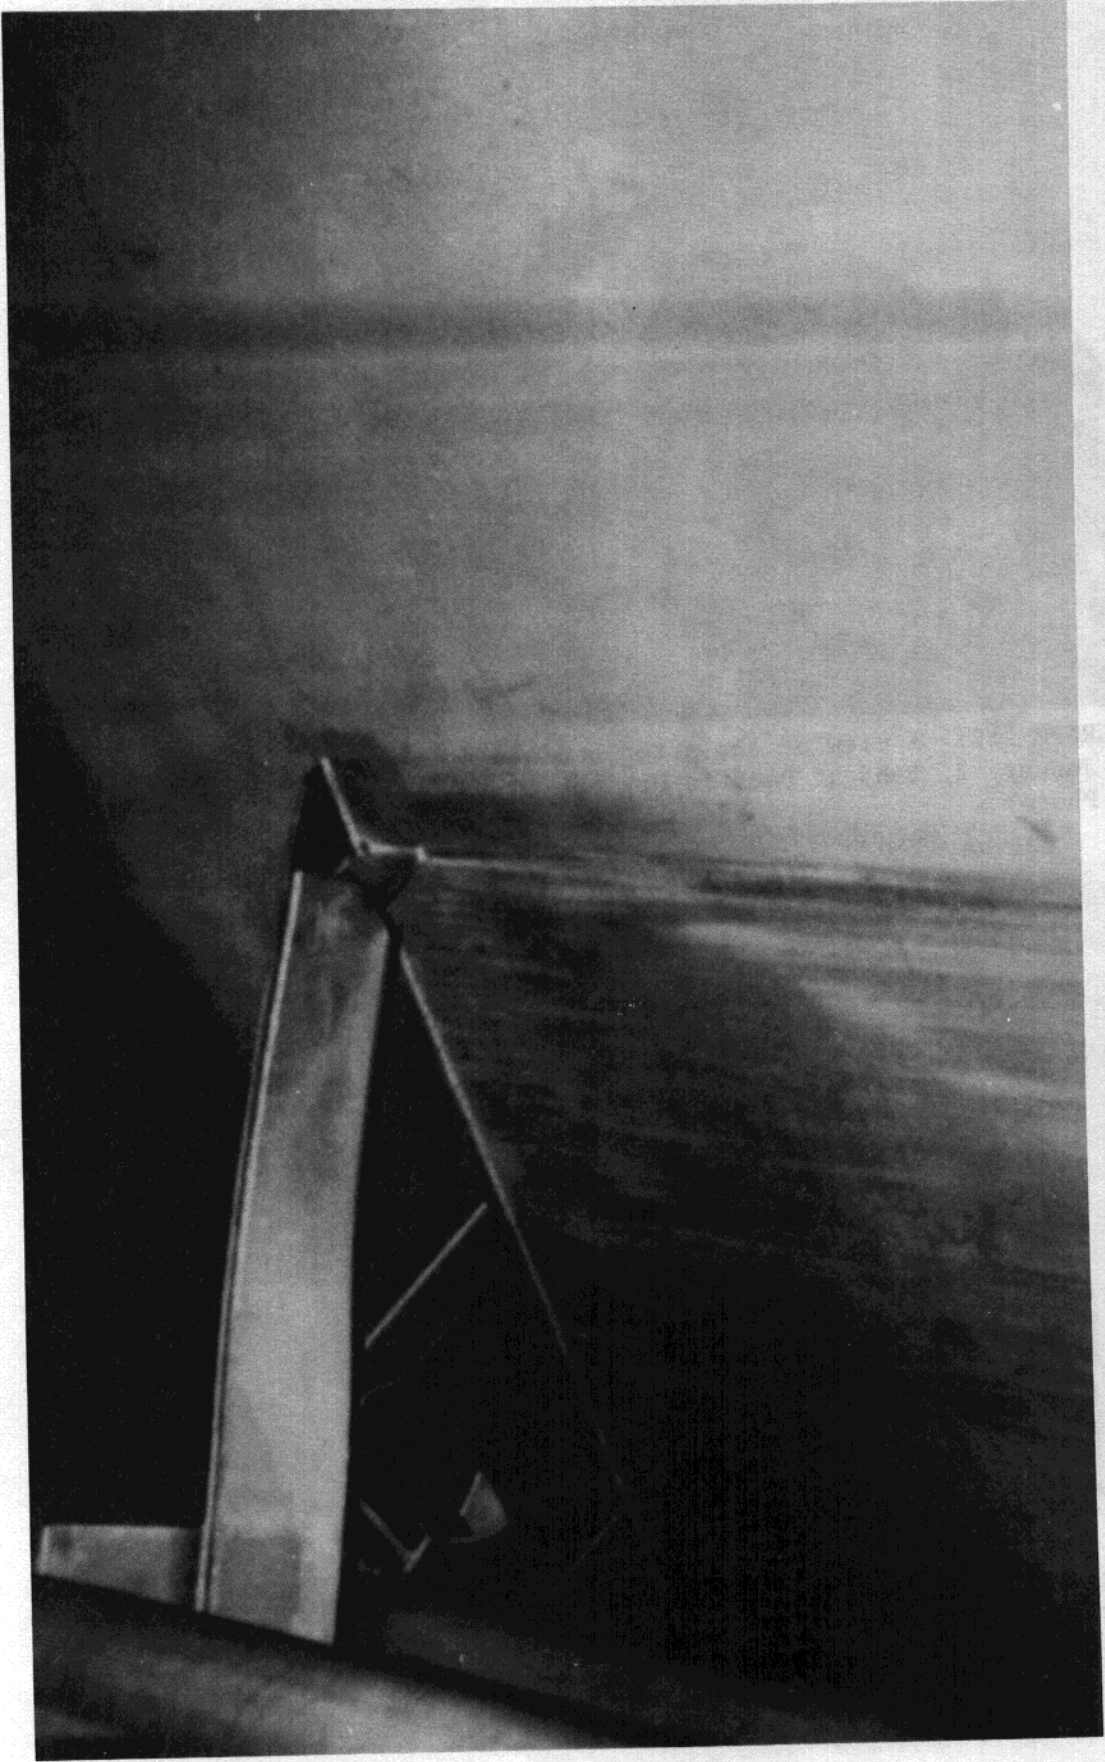
PHOTOGRAPH #11: A detailed view showing the hole from the 5CP side. It is located below a horizontal stiffener plate and behind a cutout in a vertical gusset plate which are part of a horizontal corner bracket. (FaAA Photo taken November 19, 1985)

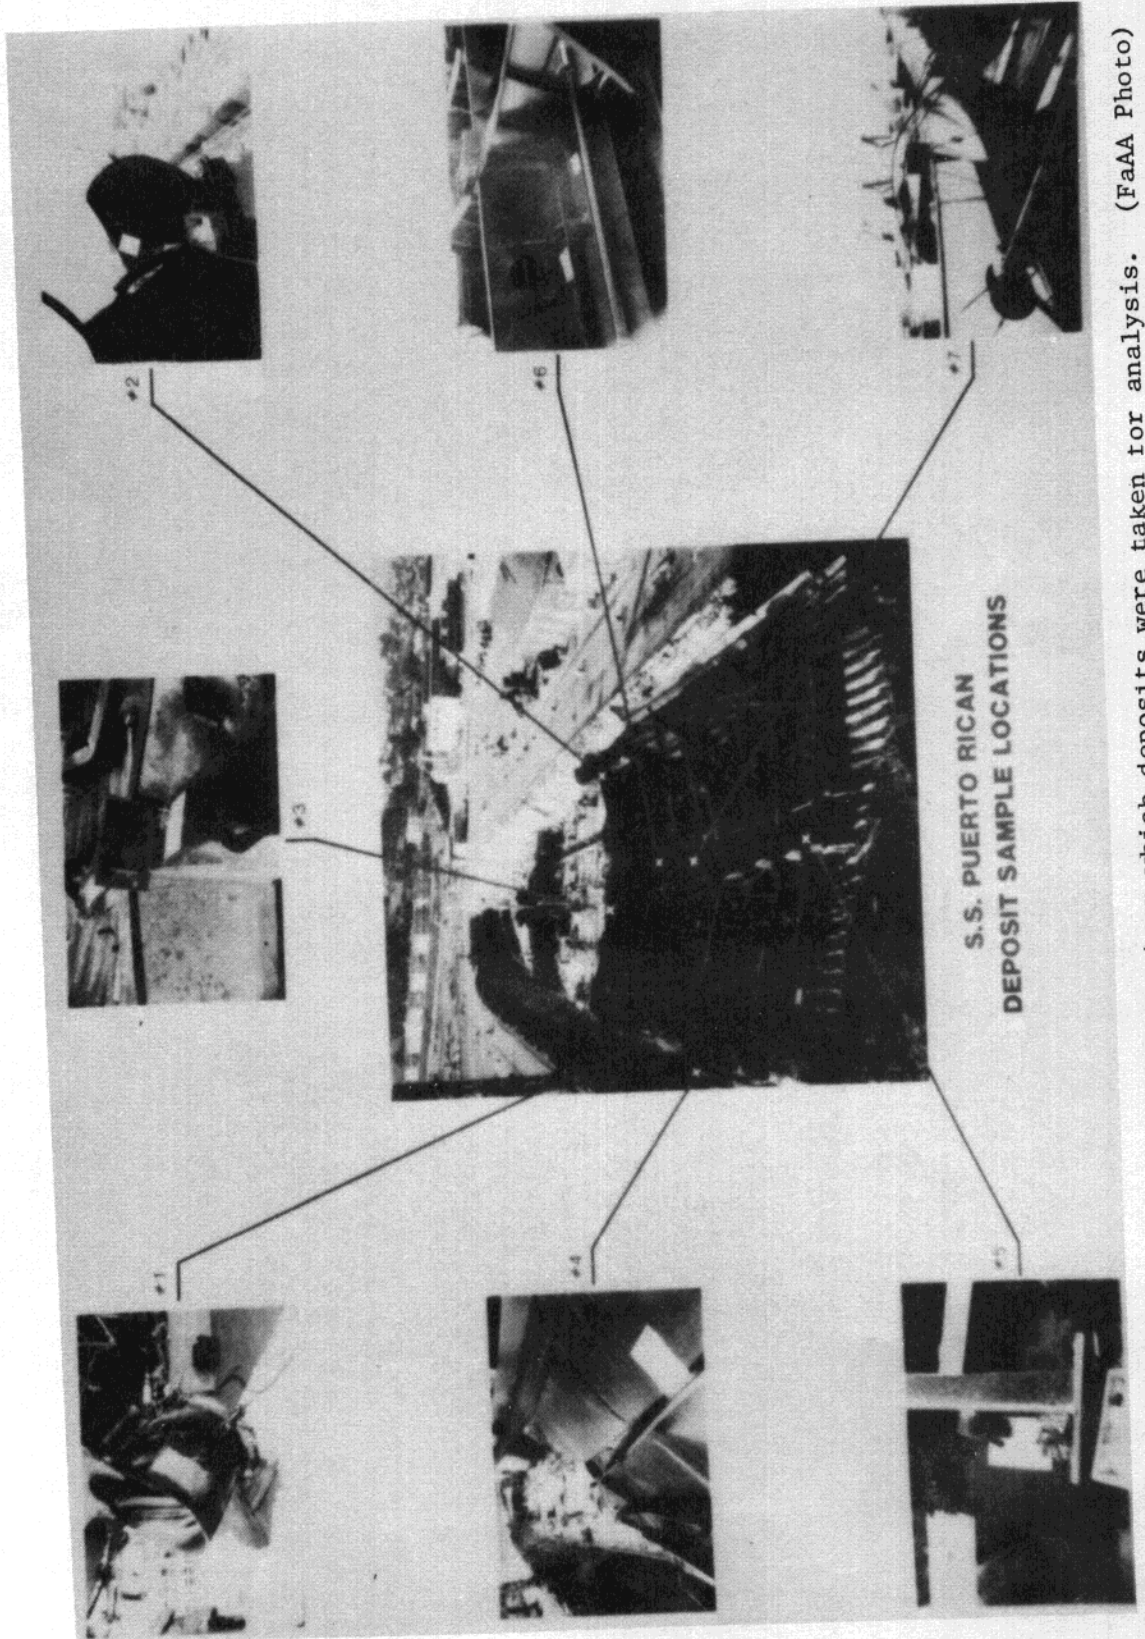
PHOTOGRAPH #14: The seven locations from which deposits were taken for analysis. (FaAA Photo)
