*Historic Structures Report*

Fort Point US Coast Guard Station  
Gulf of the Farallones National Marine Sanctuary

April 1, 2008

CAREY & CO. INC.  
ARCHITECTURE

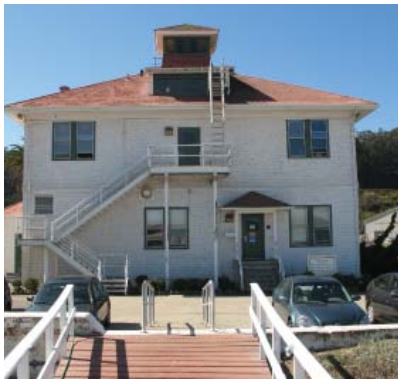
- Figure 21. Photograph: Main Boathouse, 2007. North elevation showing fire escape stair and modified bays. Carey & Co., Inc.
- Figure 22. Photograph: Main Boathouse, 2007. East elevation showing the upper levels. Carey & Co., Inc.

Fig. 21 : North elevation of the Main Boathouse.

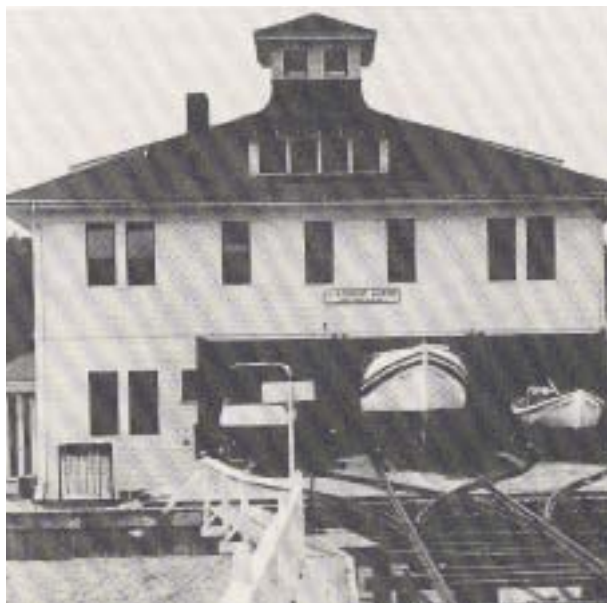
*Fig. 37 : North elevation, the original window configuration of the Life Safety Station, 1919.*

and exhibiting a full size life saving boat in front of the building could be a core element of cultural interpretation (see figures 37 & 38).

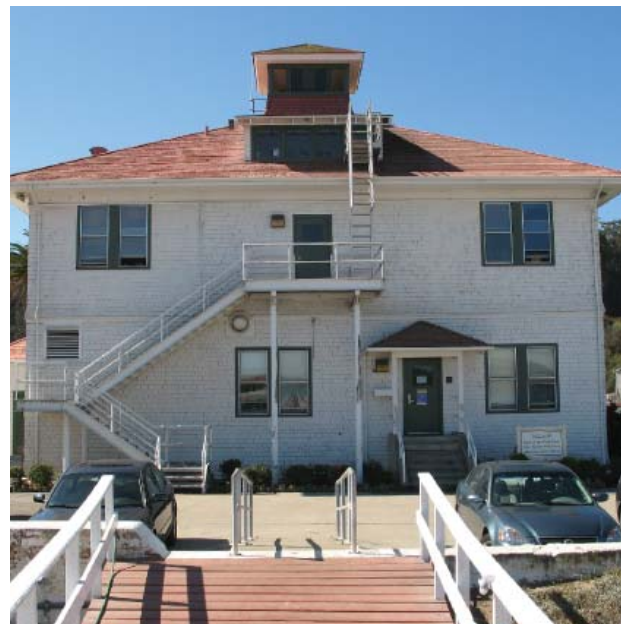
*Fig. 38 :North elevation, the current window configuration of the Life Safety Station.*

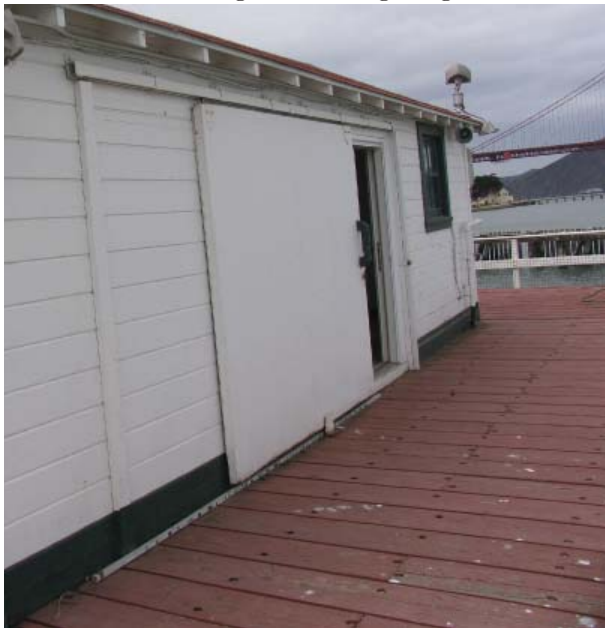
Fig. 47: Sliding wooden door at the Buoy Shack

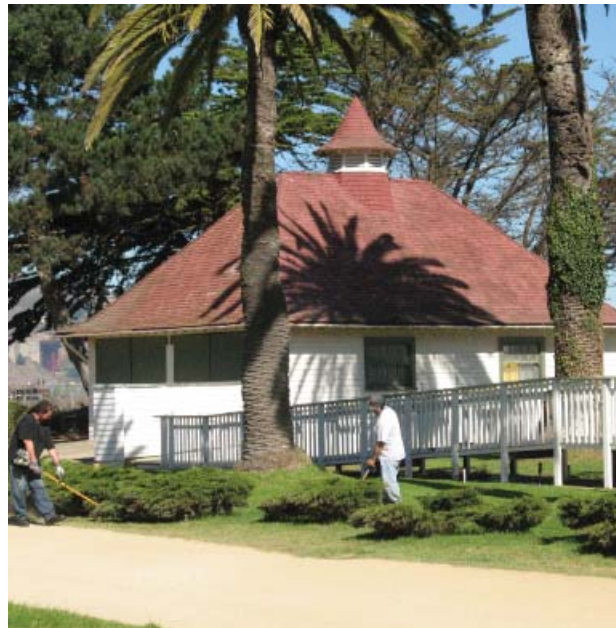
*Fig. 58: Surrounding vegetation at the 1890 Boathouse.*

Recommendations: Cut back trees and bushes in contact with the buildings. Swinging tree branches could cause impact damage. Roots can damage building foundations, underground building services and drainage systems. Additionally, vegetation can hold moisture against the buildings, providing an ideal climate for biological growth. Proposed landscape plans should use historic landscaping as a guide.

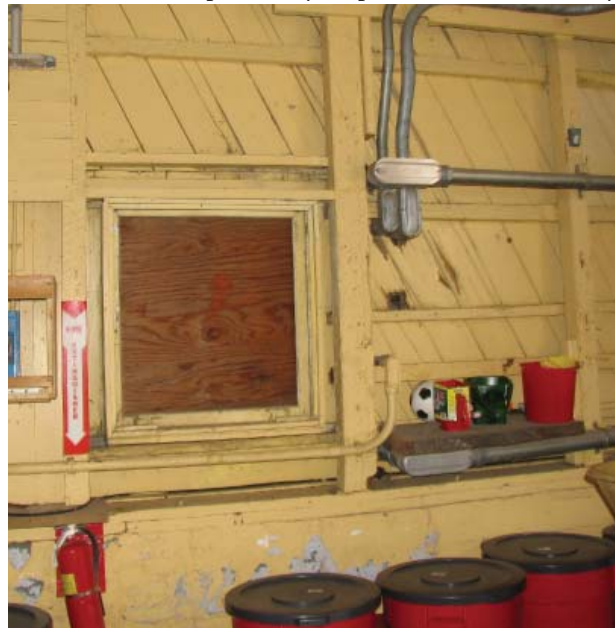
*Fig. 62 : Diagonal board walls at the Shop & Garage.*

Description: The walls of the Buoy Shack, the Tide Gauge House, and the Main Boathouse are vertical beadboard (see figure 61). The walls of the Shop & Garage, and the 1890 Boathouse are board (see figure 62). All of the walls are painted.

Condition: The conditions of the wood walls are generally good. Some are marked by ghosts of earlier building configurations, and/or have miscellaneous inappropriate attachments.

Recommendations: Repair wood wall cladding as follows:

- Conduct a detailed, wall survey to document condition of each elevation and determine, on an individual basis, required repairs.

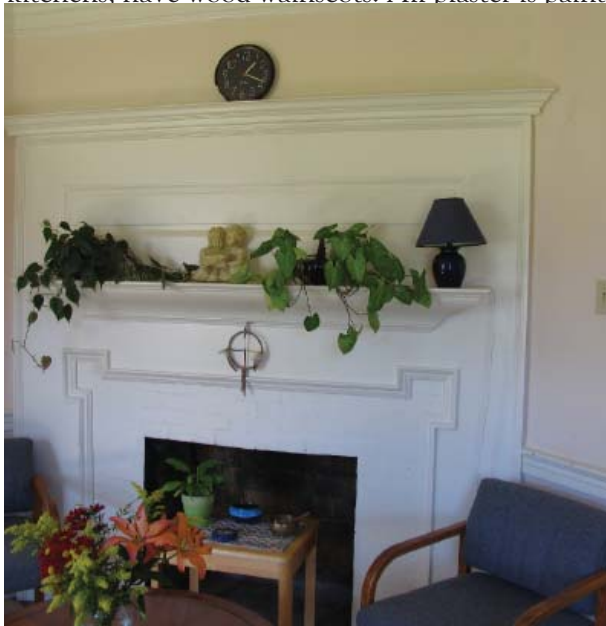
*Fig. 63 :Painted wood fireplace, mantle, and wooden elements at the Officer in Charge Quarters.*

Description: All interior plaster and woodwork is currently painted (see figures 63 & 64).

Condition: The interior finishes are in fair condition, showing signs of normal wear and tear such as chipping and scratching.

Recommendations: Following thorough preparation, including the removal of loose, flaking or chalking paint, prime the walls using a high-quality primer. Follow with two coats of quality acrylic paint. If the existing paint contains lead, follow all regulations for worker protection and material disposal. In most cases, well-adhered lead paint may be left in place and encapsulated, rather than completely abated.

Strip paint from originally clear-finished woodwork. Refinish with varnish to match color and gloss of historic material. This will involve preparing samples of available stains and varnishes on substrates similar to the woodwork, and comparing them to historic varnishes prior to stripping.

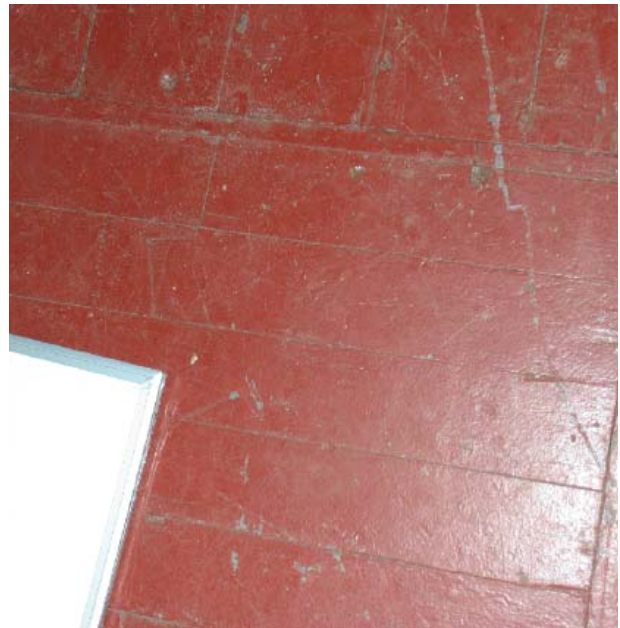
Fig. 66 : Original wood flooring at the Shop & Garage.

& Garage, Buoy Shack, and Tide Gauge House are clear finished wood. The clear finished wood floors are in generally good condition; however, the floors in the 1890 Boathouse, Shop & Garage, and Tide Gauge House are in need of refinishing. Presumably, original wood flooring survives beneath the later carpeted finishes of the Officer in Charge Quarters and Main Boathouse. Wall-to-wall carpeting protects the floors; however, it makes it very difficult to verify the original flooring material and assess its condition.

Recommendation: Remove non-contributing carpet and vinyl floor finishes. Repair wood flooring as follows:

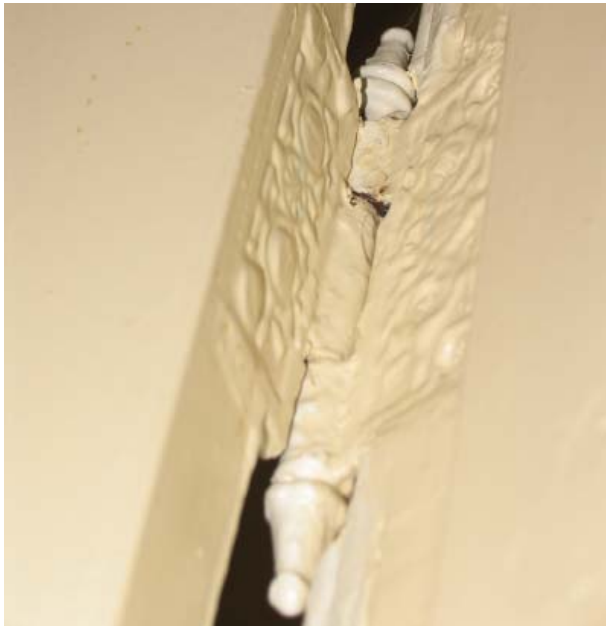
Fig. 69 : Original hardware at the Officer in Charge Quarters.

Description: The majority of the hardware is original and intact. It consists of bronze doorknobs, bronze faceplates and hinges, and bronze window catches (see figures 69 & 70). Several locks on the exterior doors have been replaced with modern dead bolt locks.

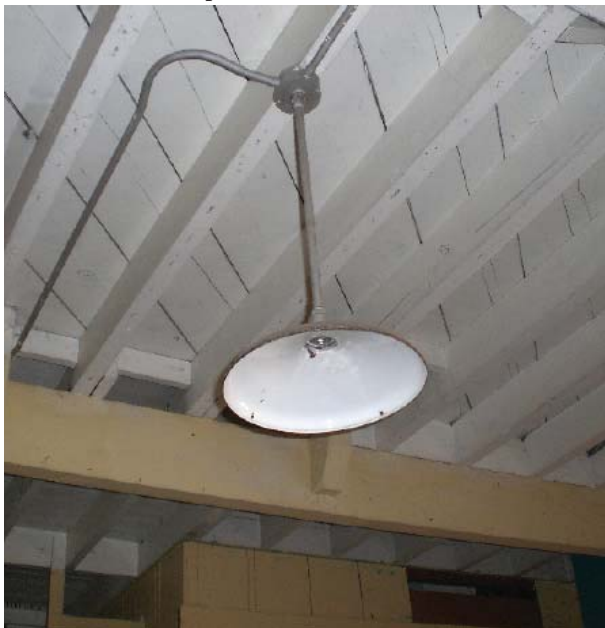
Fig. 71 : Historic pendant light fixture at the Shop & Garage.

Description: Interior light quality directly affects the perception of both space and material finishes. Existing light fixtures include historic exposed single-bulb hanging pendant fixtures in the Shop & Garage;

and later, non-historic exposed single-bulb hanging pendant fixtures and ceiling-mounted fluorescent light fixtures, in the other buildings (see figure 71).

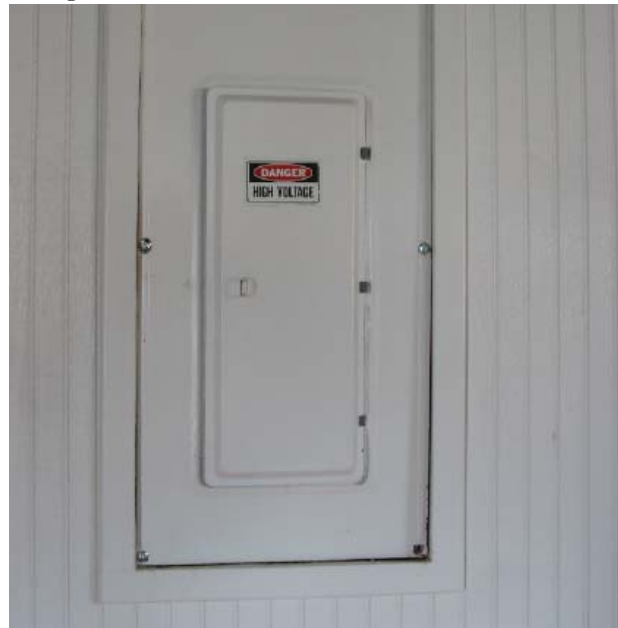
Fig. 72 : Electrical box at the Buoy Shack.

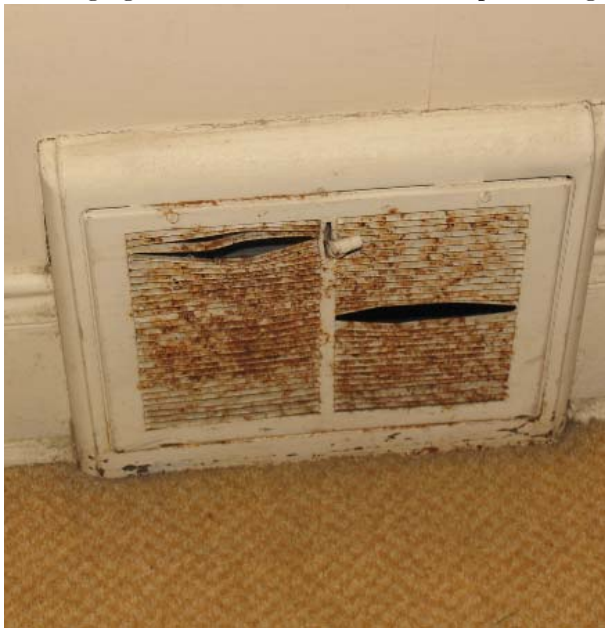
Fig. 73 :Heater vents at the Officer in Charge Quarters.
