MARINE CASUALTY REPORT

TANKSHIP PUERTO RICAN

**EXPLOSION AND FIRE
IN THE PACIFIC OCEAN,
ON 31 OCTOBER 1984**

REPORT NO. USCG 16732/0003 HQS 84

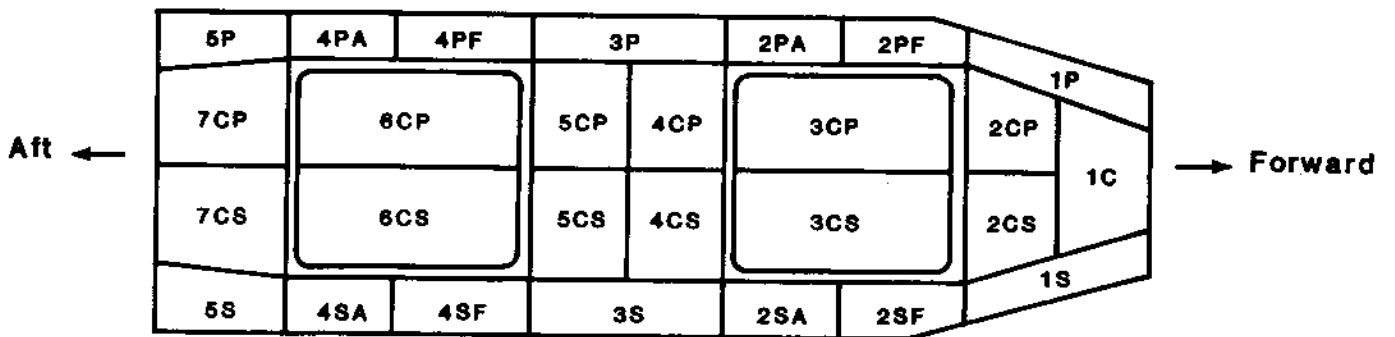
Figure 1. Schematic plan of cargo tanks on the S.S. Puerto Rican.

7. The PUERTO RICAN was a steel tank vessel with special tanks and tank linings for the carriage of specified chemicals and liquefied gases. The deckhouse was located aft and above the machinery space. It contained the navigation bridge, radio room, and quarters for the entire complement of officers and crew. An eductor room, located below the main deck on the centerline of the vessel between the engine space and the aftermost cargo tanks, serviced the double bottom sea water ballast tanks. The cargo control room was located on the port side of the main deck centerline next to the foam room and immediately forward of the deckhouse. The forebody was divided into 27 cargo tanks. The cargo tank arrangement and numbering system is shown in figure 1.

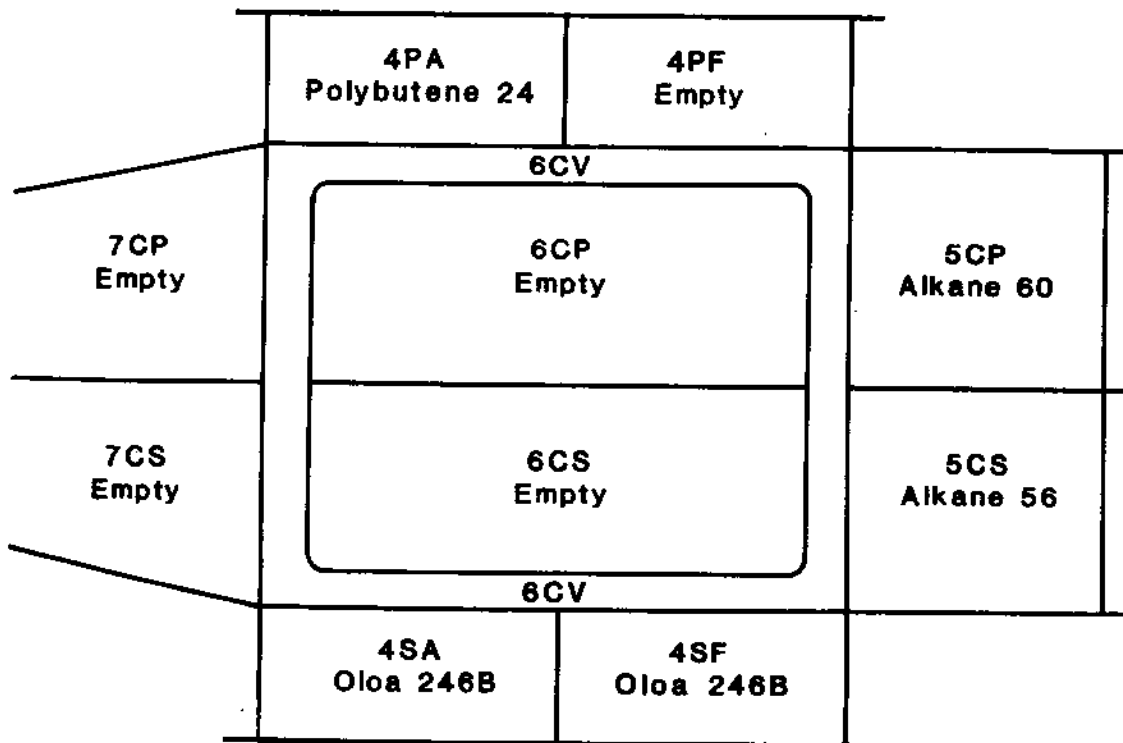
Figure 2. Cargoes in the tanks adjacent to 6CV, at the time of the casualty.

26. The cargoes immediately adjacent to 6CV on October 31, 1984 are shown in figure 2.

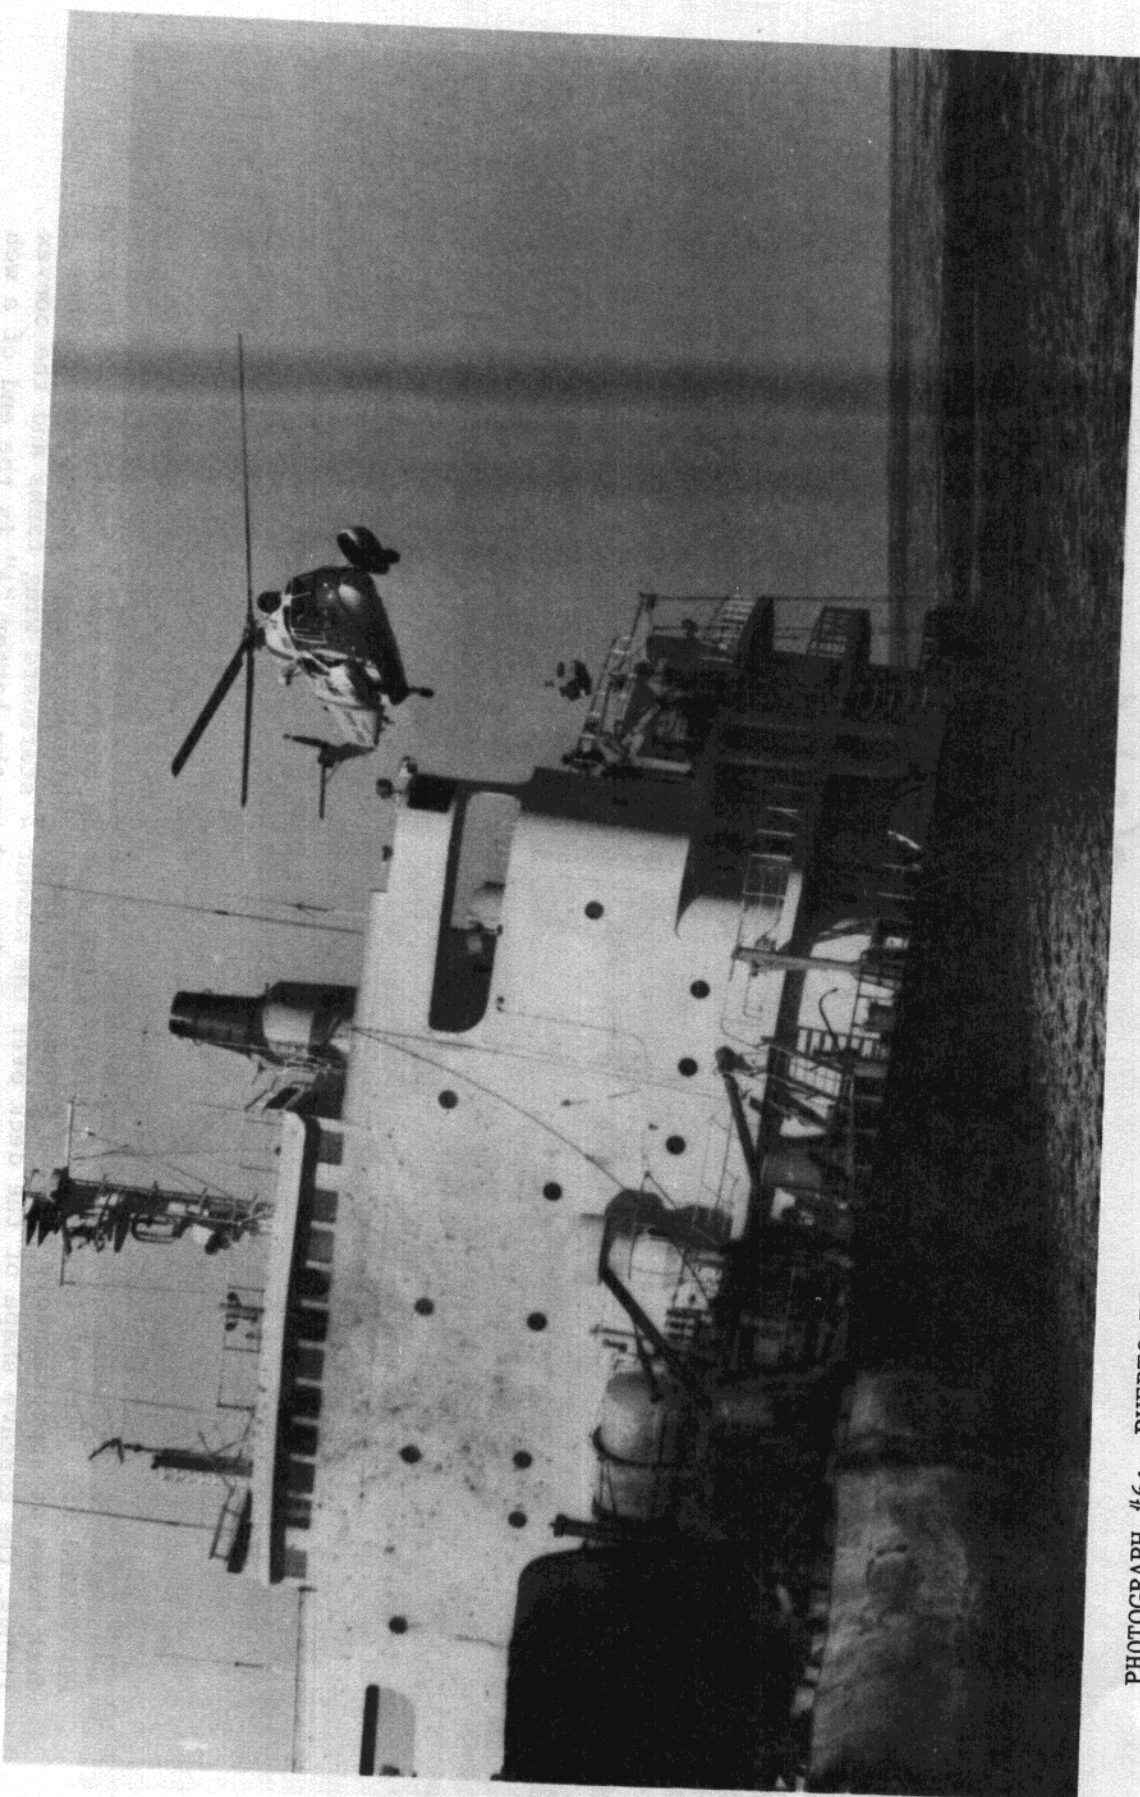
114. Almost immediately after the explosion, Captain SPILLANE re-entered the pilothouse. There were eleven windows across the front of the bridge area. Four of the five center windows were blown out. This is shown in photograph 6. He sounded the general alarm and rang for water on the firemain and the foam systems. The emergency generator had come on-line almost immediately following the explosion. Though the engine order telegraph on the

PHOTOGRAPH #6: PUERTO RICAN under tow on November 1, 1984 at approximately 1000 in position approximately 35.5 miles and 215°T from Point Bonita. (USCG Photo)

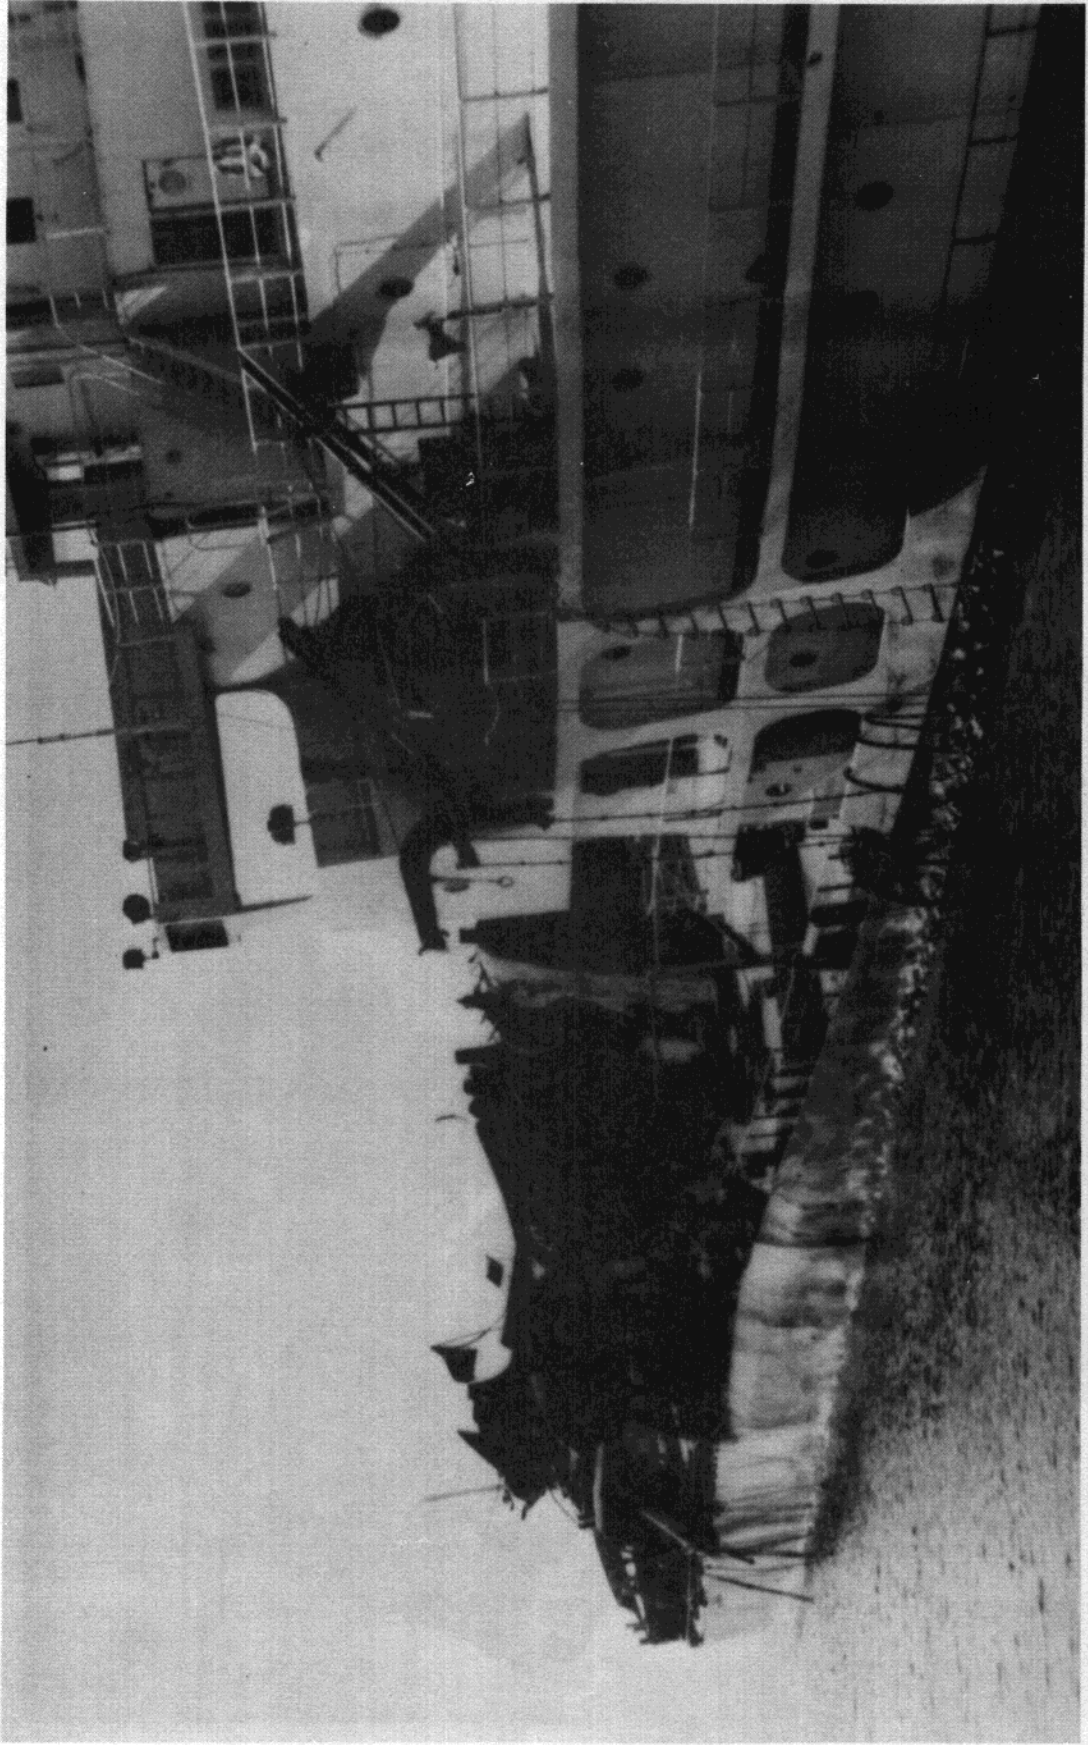
arrived, the freeboard at the stern was approximately ten feet. Approximately 30 minutes later, at about 0445, the freeboard was reduced to five feet. He noted that, although the freeboard at the stern had decreased, the forebody was still relatively level. The stern section was now also listing to port. Though it was racked to port, he never heard any cracking of the hull. When Captain SPILLANE, the last person to be removed, attempted to board the HARRY M from the stern of the PUERTO RICAN, he had to step on a chock and jump up to the bow of the HARRY M. The orientation of the forebody and the stern section is shown in photographs 7 and 8.

PHOTOGRAPH #7: PUERTO RICAN November 1, 1984 at approximately 0930 in position approximately 35.5 miles at 215°T from Point Bonita. (USCG Photo)

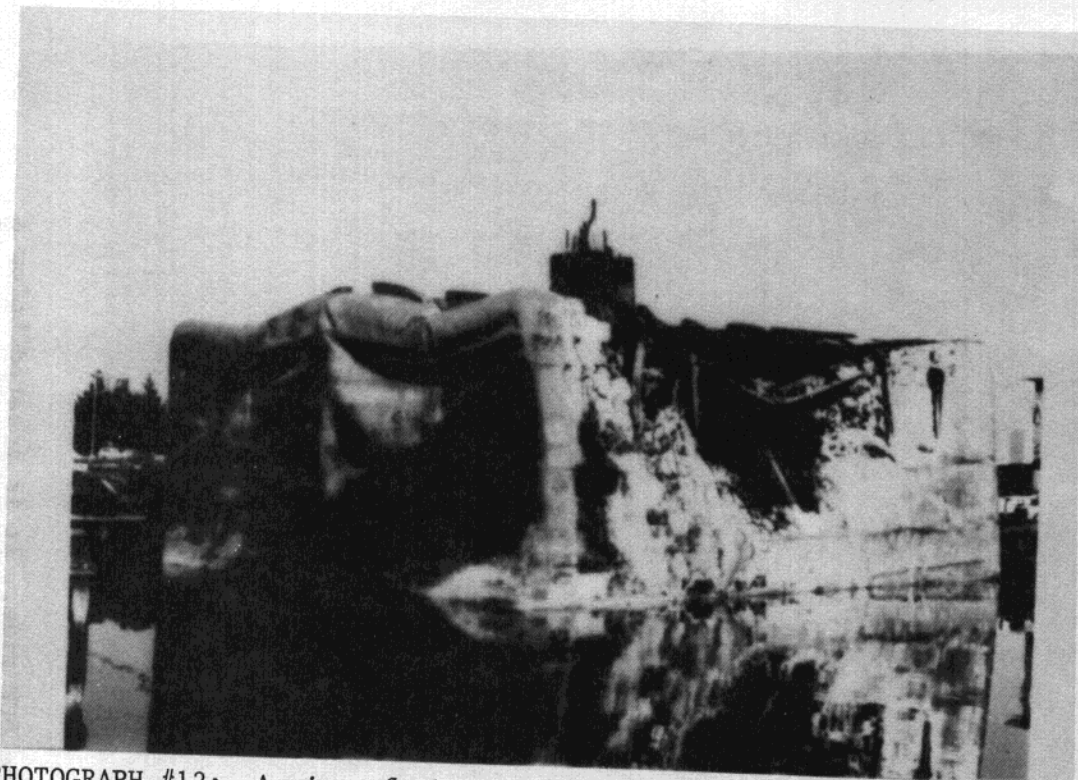
195. The Board examined the 6C independent tank on November 6, 1984, while it was afloat at Pacific Drydock and Repair, Oakland, California. See photographs 12 and 13. The top of the tank and after transverse bulkhead were dished inward on either side of the tank's centerline longitudinal watertight bulkhead. The forward transverse side received minimal structural damage. The upper portion of the port and starboard sides, including the upper knuckle area, were buckled near the tank's transverse centerline. The bottom and the lower 3 feet of the sides of the tank were undamaged, and the nominal 3 inch polyurethane insulation covering this area was intact and undamaged by the fire. All other polyurethane insulation was either charred significantly or burned away completely. The sidshell and top plating was dented and penetrated in several locations. All penetrations in the plating were small, consisting of approximately 1-foot tears. No evidence of damage resulting from a point source explosion was found.

PHOTOGRAPH #12: A view of the after end and starboard side of 6C; taken January 2, 1985 at Pacific Drydock Co., Oakland, CA. (FaAA Photo)
